Ottawa Beach Road Study

**Prepared For:
Park Township**

**September 30, 2014
Project No. G140303**

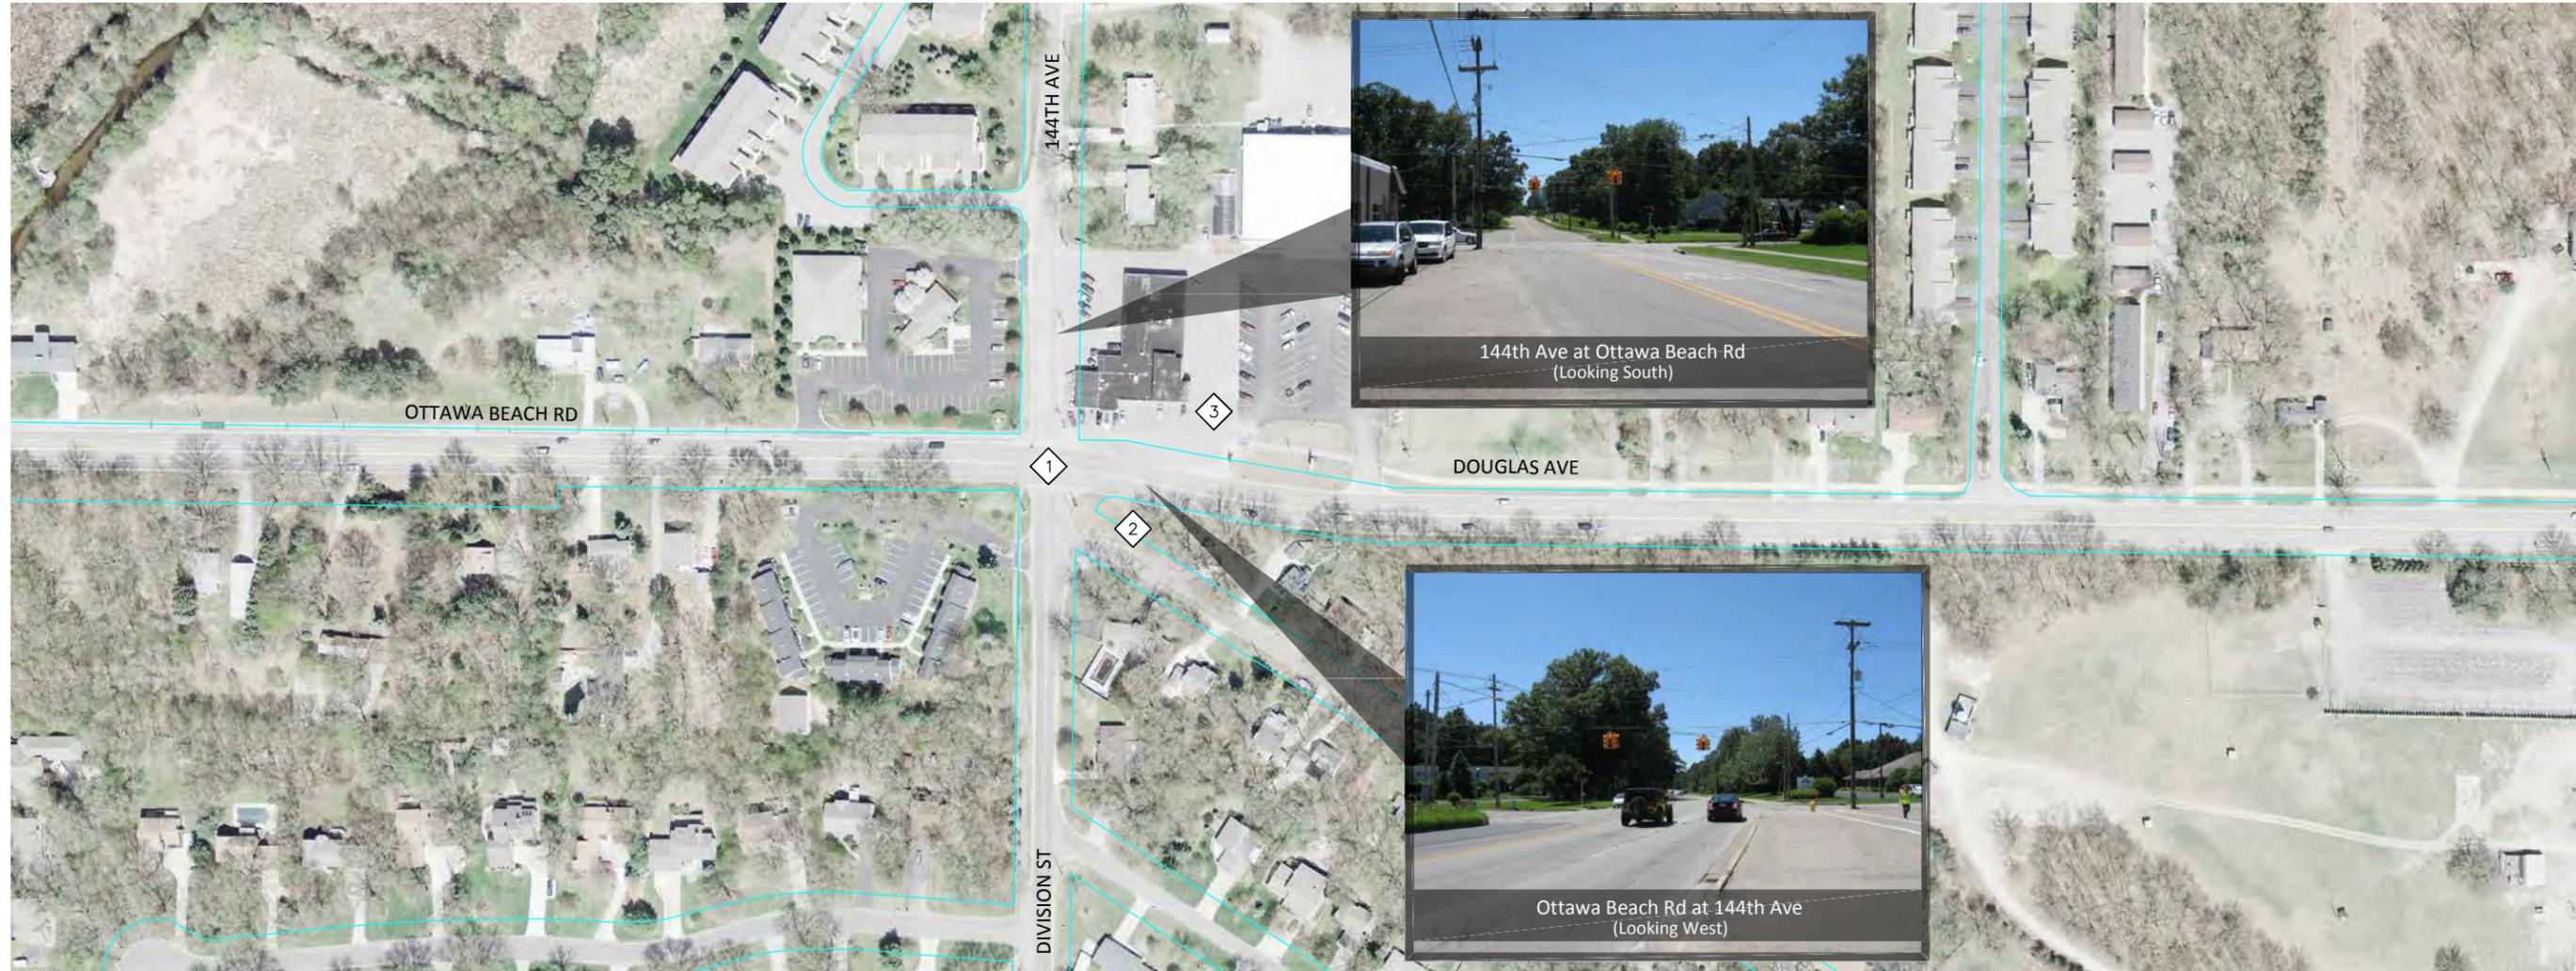
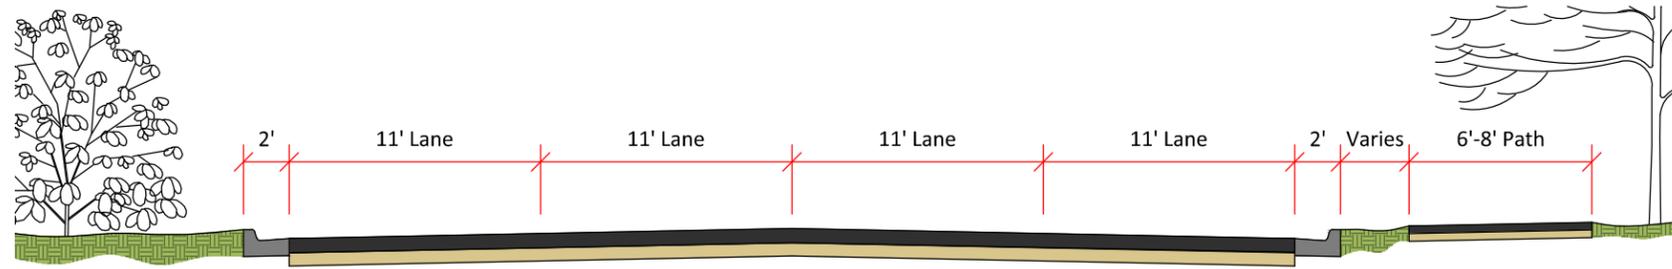
**144TH AVENUE
EXISTING CONDITIONS**

It was observed that sight-lines were restricted due to curve in Ottawa Beach Road that occurs at the intersection. The crash analysis review confirmed the sight-lines maybe a contributing factor to the crashes.

EXISTING CROSS SECTION
OTTAWA BEACH RD (LOOKING WEST)

| <p>OTTAWA BEACH RD CORRIDOR</p> <ol style="list-style-type: none"> The posted speed limit is 45 mph. Parking is prohibited on both sides of the road. | <p>OTTAWA BEACH RD AND 144TH AVE</p> <ol style="list-style-type: none"> Sight lines are restricted due to the curve in the road. During data collection, it appeared the intersection was staked to be reconstructed. |

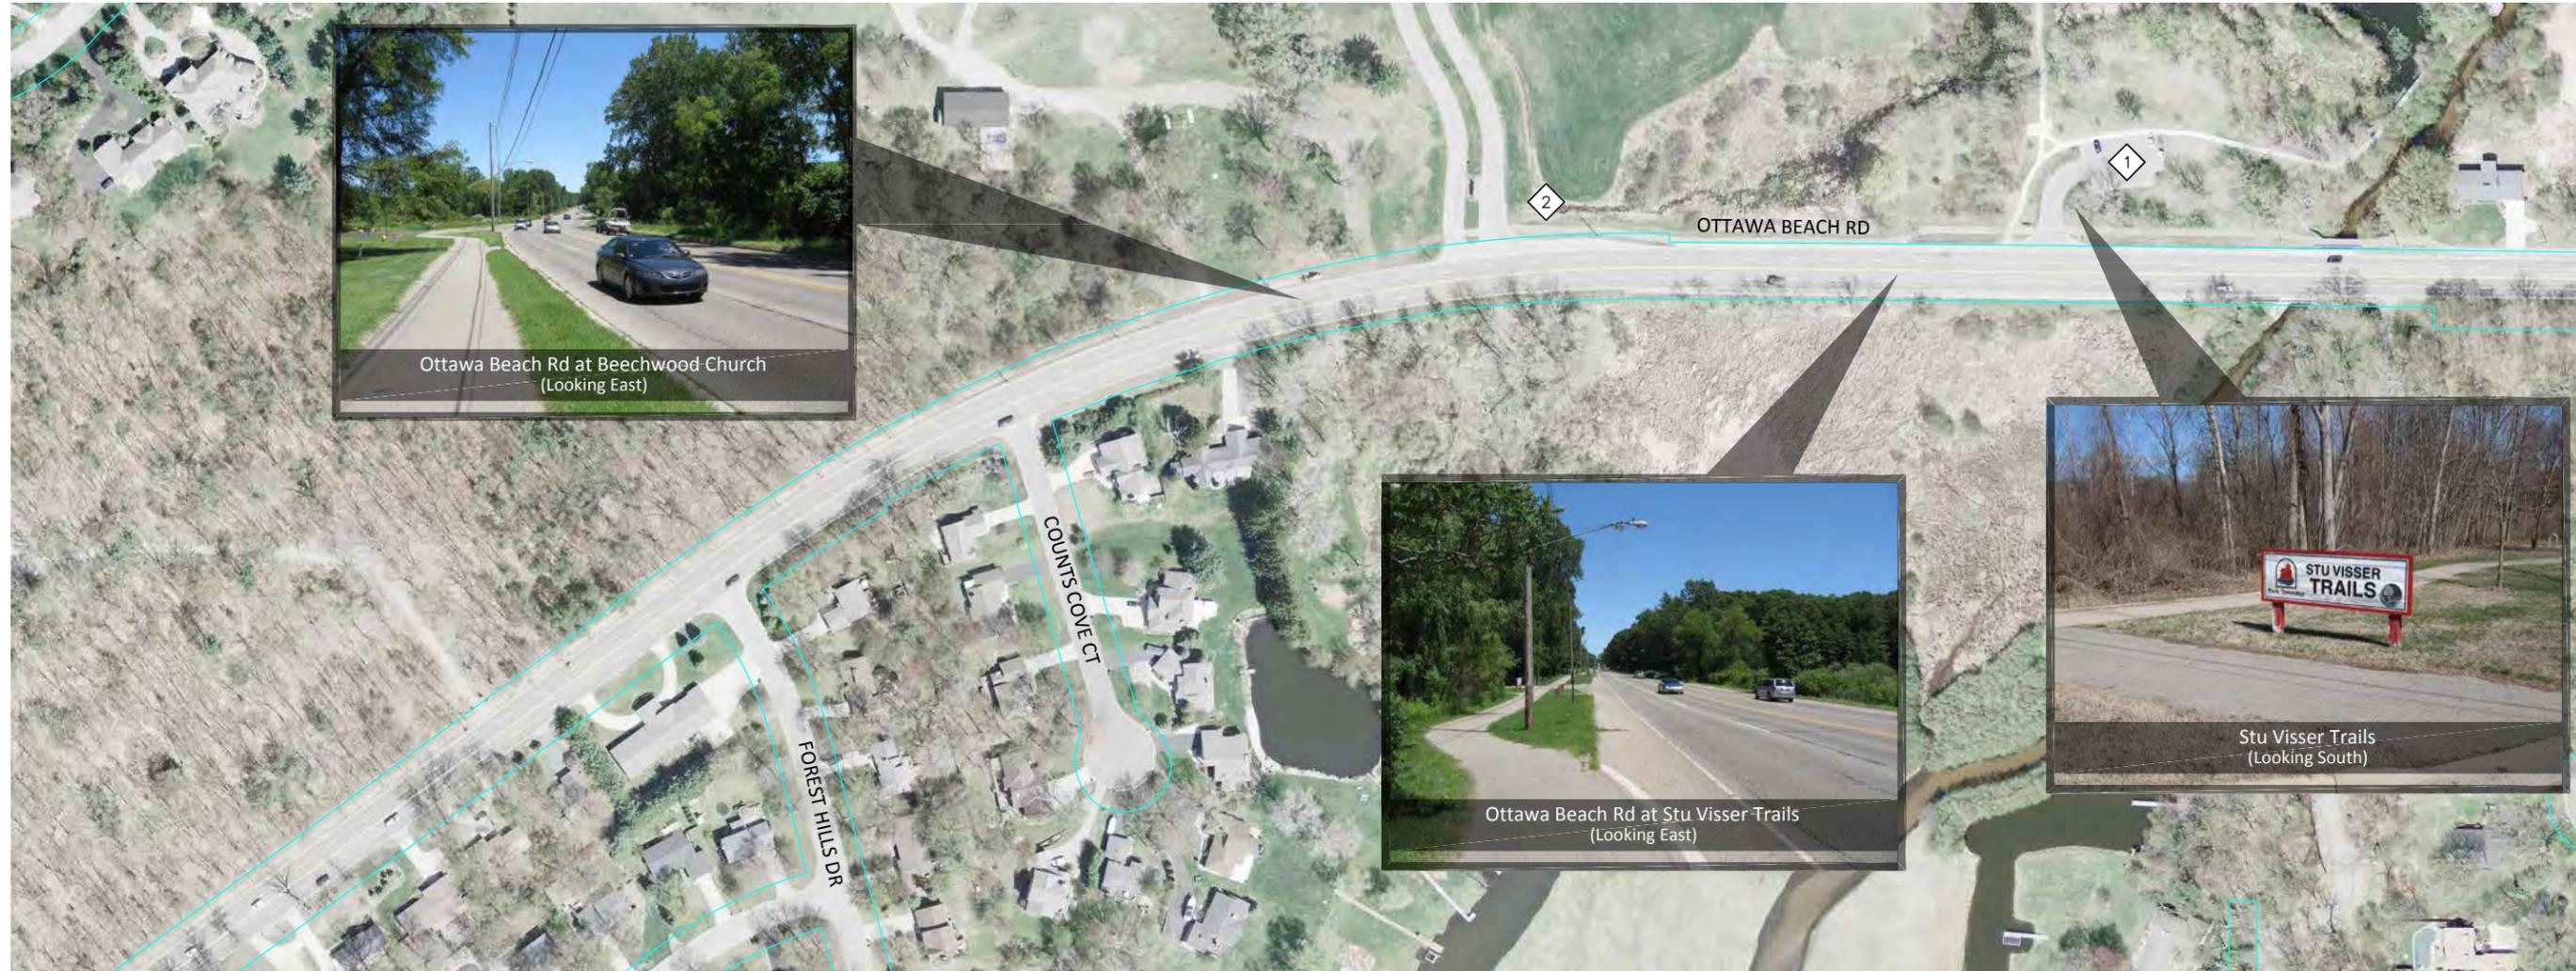
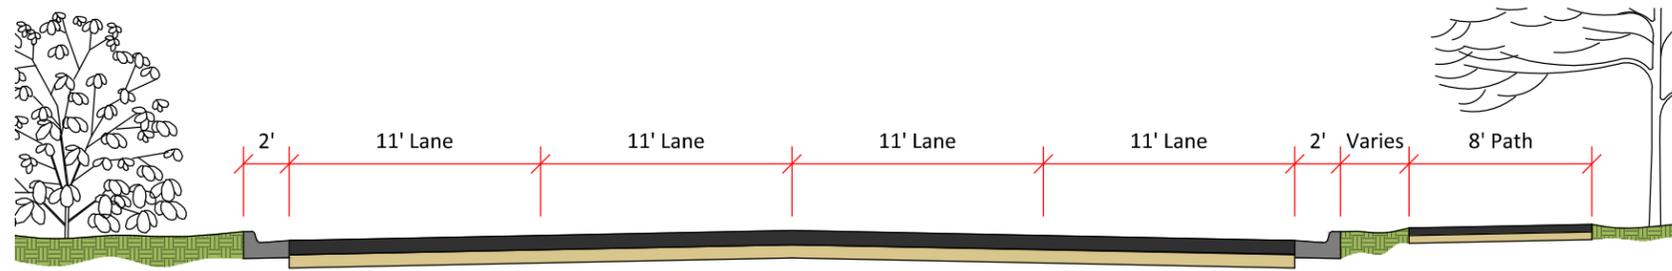
EXISTING CROSS SECTION
OTTAWA BEACH RD (LOOKING WEST)

- KEY NOTE LEGEND**
- ◆ Stu Visser Trails parking lot and trailhead.
 - ◆ Beechwood Church Entrance.

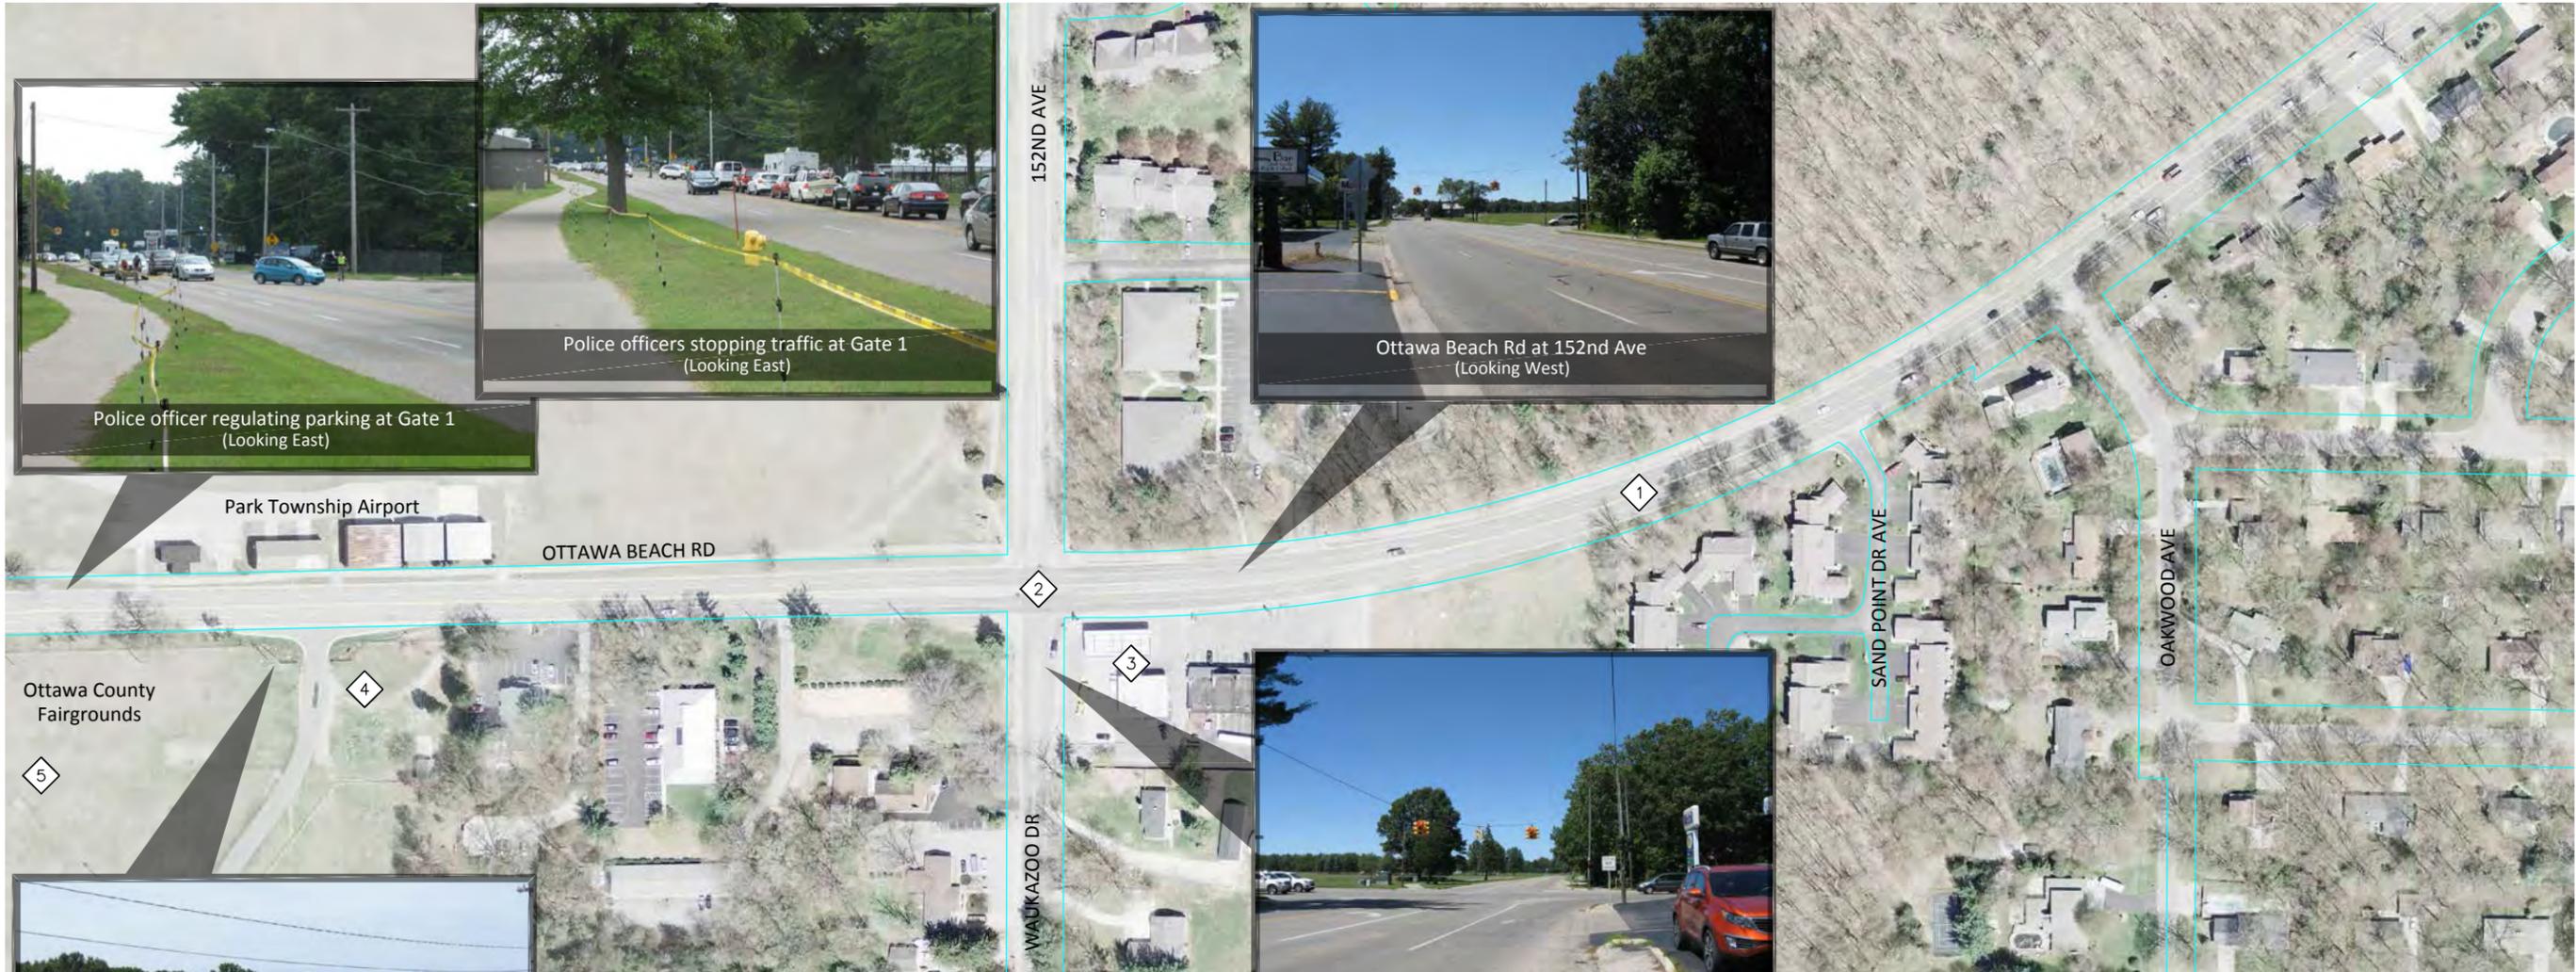
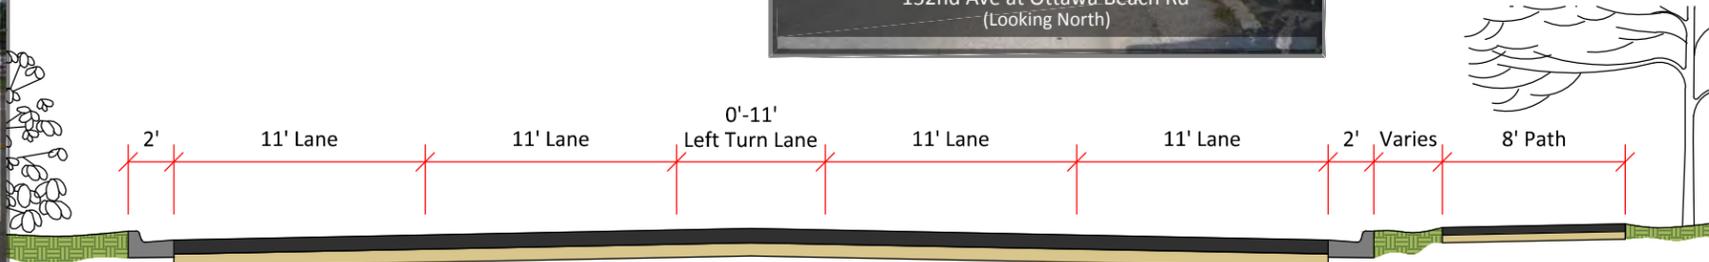
The Ottawa Beach Road and 152nd Avenue intersection is a signalized intersection located near the airport and fairgrounds. Sidewalks were not present on the southeast corner and all sidewalk ramps at the intersection were not ADA compliant. Crosswalk markings were found to be faded for the crossings at the intersection.

EXISTING CROSS SECTION
OTTAWA BEACH RD (LOOKING WEST)

- KEY NOTE LEGEND**
- ◆ 1 Tube Counter Location 1 for volume and speed data. ADT = 16,699 vpd, 85th Percentile Speed = 57 mph
 - ◆ 2 The intersection is signalized. All corners have pedestrian signals.
 - ◆ 3 Sidewalks are not present on the SE corner and all sidewalk ramps at the intersection need to be updated to be ADA compliant.
 - ◆ 4 Dog Park and Skate Park entrance. Gate 1 Entrance for the Ottawa County Fair. See photo.
 - ◆ 5 Gate 1 parking area.

- NOTES**
- OTTAWA BEACH RD CORRIDOR**
- The posted speed limit is 45 mph.
 - Parking is prohibited on both sides of the road.
- OTTAWA BEACH RD AND 152ND AVE**
- Dedicated left-turn lanes are provided on Ottawa Beach Rd.
 - Traffic backs up to intersection during Ottawa County Fair when police officers stop traffic at entrance gates. See photo.
- OTTAWA COUNTY FAIRGROUNDS**
- Gate 1 Entrance was closed until 4:00 p.m. on Friday. Gate 1 was used for private picnic parking only on Saturday.
 - Police officers regulated parking for the private picnic and stopped traffic on Ottawa Beach Rd for vehicles entering Gate 1. See photos.

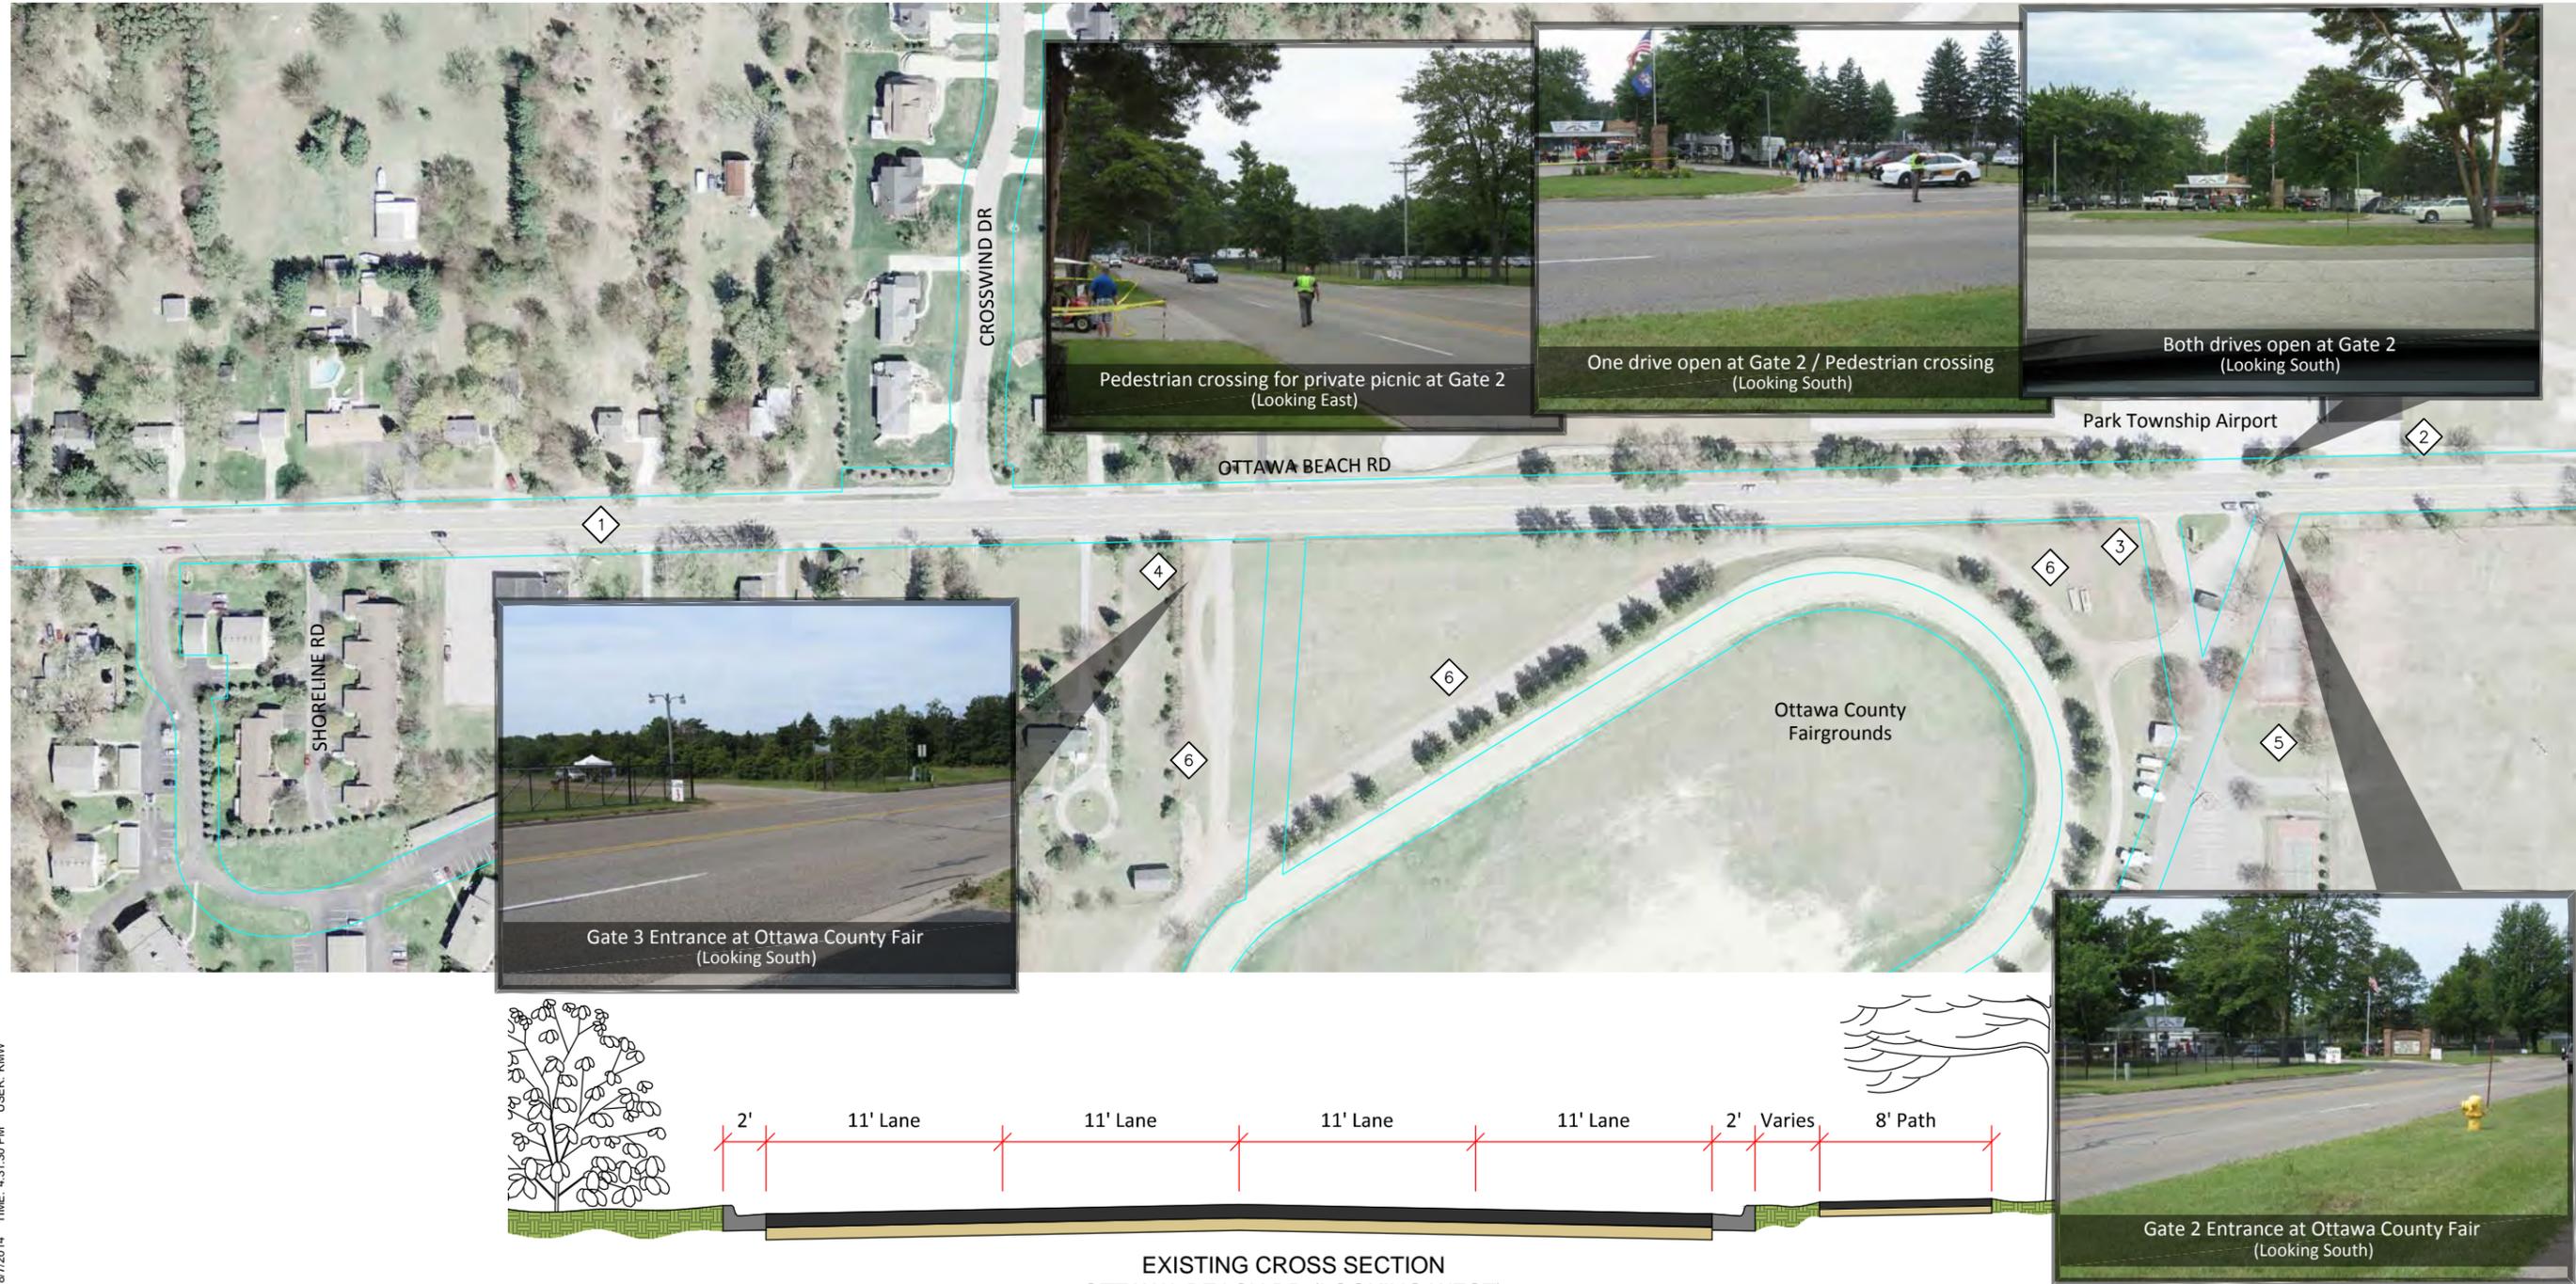
It was observed during data collection that the Gate 1 Entrance was closed until 4:00 p.m. on Friday. On Saturday, Gate 1 was used for private picnic parking only. The Gate 2 Entrance used both drives on Friday and west drive was closed for part of Saturday. The Gate 3 Entrance was open at all times and was the only entrance that could be used by vehicles with trailers.

Event signing and guidance was deficient for some of the fair activities, which caused some confusion for visitors at the driveways.

- KEY NOTE LEGEND**
- 1 Tube Counter Location 2 for volume and speed data. ADT = 14,552 vpd, 85th Percentile Speed = 47 mph
 - 2 The path continues through the Airport parking lot which conflicts with drive and parking operations.
 - 3 Gate 2 Entrance for the Ottawa County Fair. Three pay lanes at Gate 2. See photo.
 - 4 Gate 3 Entrance for the Ottawa County Fair. Vehicles with trailers can only use Gate 3. See photo.
 - 5 Handicapped parking area accessed by using Gate 2.
 - 6 Drive used for Gate 2 and 3 parking area in the back of the Fairgrounds.

- NOTES**
- OTTAWA BEACH RD CORRIDOR**
- The posted speed limit is 45 mph.
 - Parking is prohibited on both sides of the road.
- OTTAWA COUNTY FAIRGROUNDS**
- Gate 2 Entrance used both drives on Friday. The west drive at Gate 2 was closed part of Saturday. See photos.
 - A private picnic was held on Saturday at the airport. A tape fence was set up along the path to direct pedestrians to cross at Gate 2 which was regulated by a police officer and event staff. See photos.
 - Several event staff on carts were in the area. Carts were also used to transport pedestrians from the private picnic at the airport to the fair.

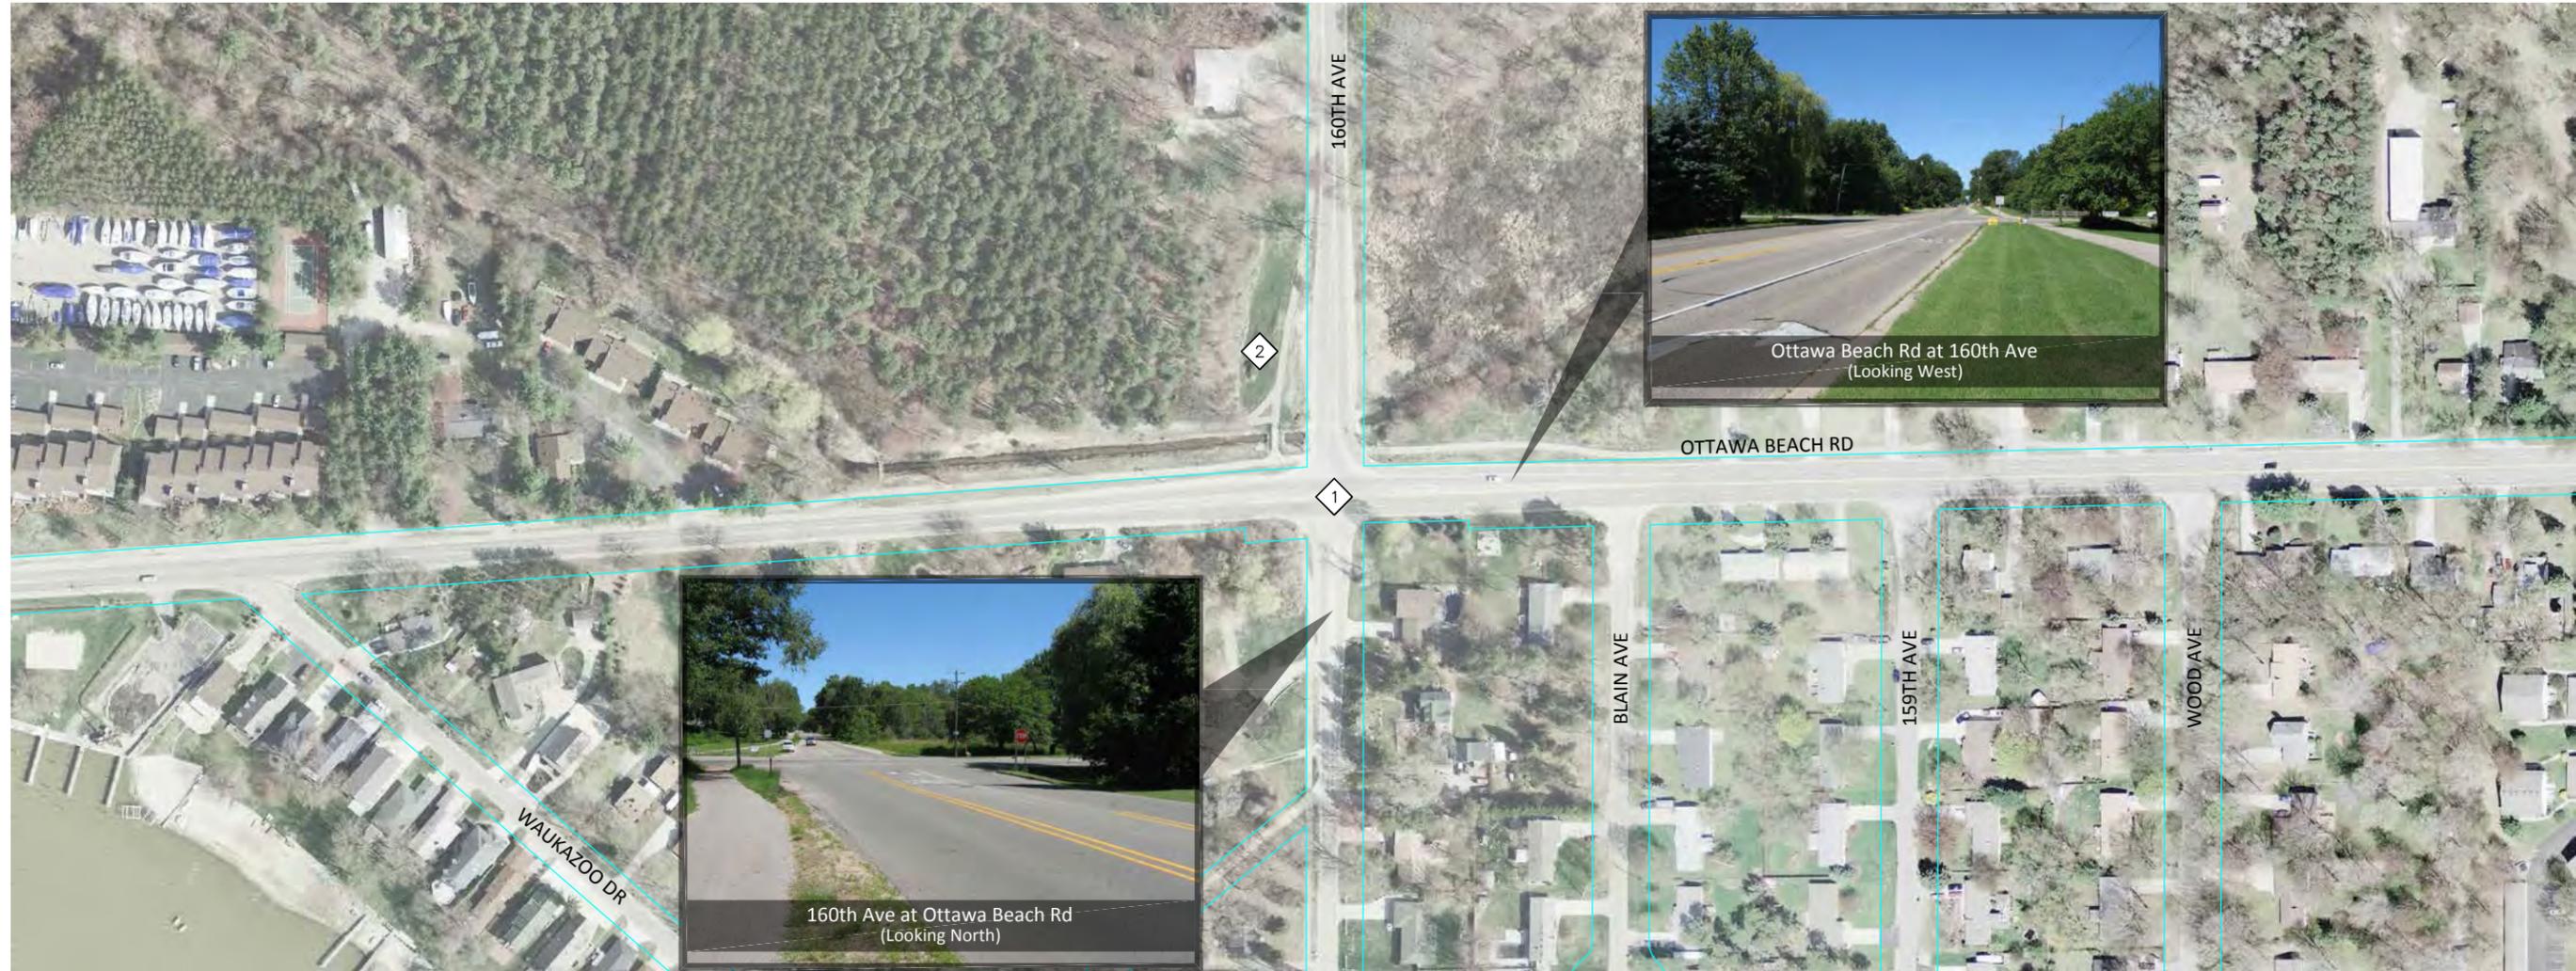
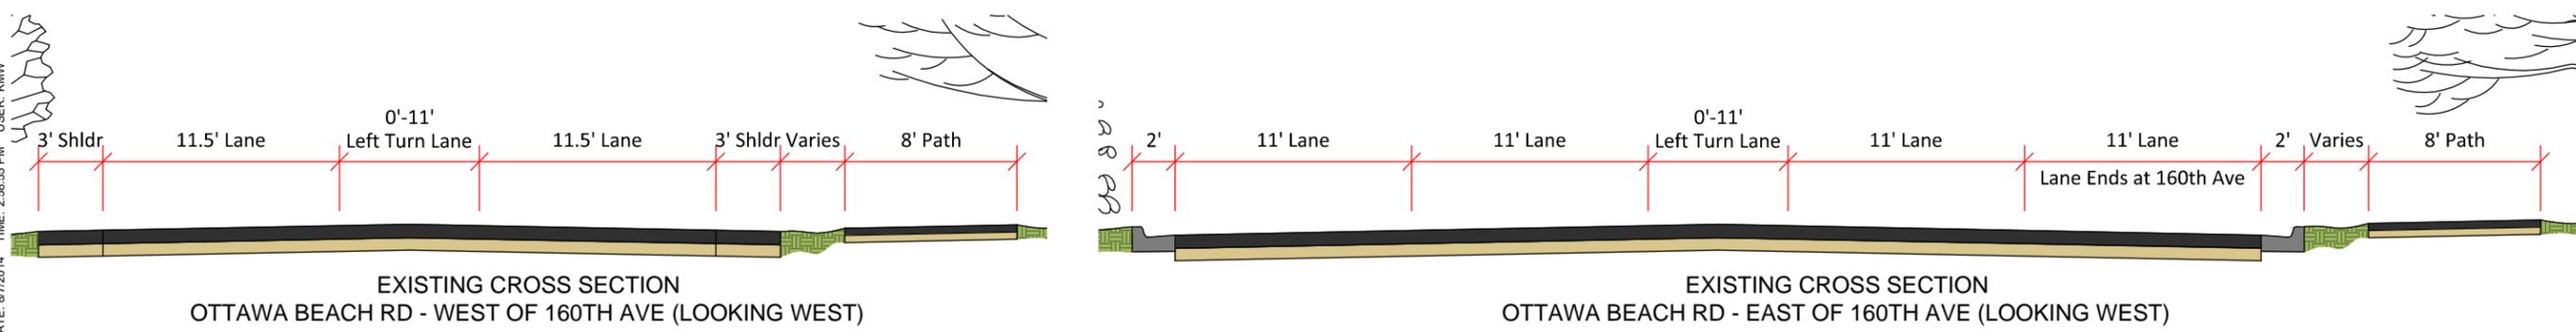
Ottawa Beach Road transitions from a four-lane road to a two-lane road at 160th Avenue. The WB right lane drops at 160th Avenue and becomes a right turn lane for vehicles heading northbound (NB) on 160th Avenue. This is considered a near-side intersection lane drop. Several WB vehicles were observed to merge once in the right turn lane or in the intersection. This is an operational and potential safety concern as many vehicles were observed cutting off traffic.

Two multi-use paths cross at the northwest corner of the Ottawa Beach Road and 160th Avenue intersection: the east-west path the runs along the north side of Ottawa Beach Road for the entire study area and a north-south path the runs along the west side of 160th Avenue. Crosswalk markings were found to be faded for the crossings at the intersection. Pedestrians were observed running to cross Ottawa Beach Road due to the roadway width and higher speeds on the road. Signing found on the east-west path was not compliant with correct MMUTCD standards.

During data collection, it was observed that vegetation obstructed some of the sight-lines at the intersection.

- KEY NOTE LEGEND**
- 1 The intersection is two-way stop-controlled. Ottawa Beach Rd does not stop.
 - 2 A pedestrian and bike path is located on the west side of 160th Ave.

- NOTES**
- OTTAWA BEACH RD CORRIDOR**
1. The posted speed limit is 45 mph.
 2. Parking is prohibited on both sides of the road.
 3. Ottawa Beach Rd transitions from a 4-lane road to a 2-lane road at 160th Ave. The WB right turn lane drops at 160th Ave. Several vehicles were observed to merge over once in the right turn lane or in the intersection.
- OTTAWA BEACH RD AND 160TH AVE**
1. Dedicated left-turn lanes are provided on Ottawa Beach Rd.
 2. The crosswalk across Ottawa Beach Rd is approximately 45'. Pedestrians were observed running across the road to cross since Ottawa Beach Rd does not stop and the speed limit is 45 mph.

Per MDOT Traffic and Safety Note 614D, the signing and pavement markings for a near-side intersection lane drop needs special emphasis. An advance warning sign, "Thru Traffic Merge Left" (W4-7), is recommended. Advance street name signs and special pavement markings in the dropped lane will also reinforce the advance warning sign and provide motorists with the necessary guidance to react and maneuver the vehicle safely and effectively to avoid the "trap lane". In addition, the lane control sign (R3-7F) and "Right Lane Must Turn Right" (R3-7R) support the use of the right turn lane. Signs and pavement markings should be installed per MDOT Traffic and Safety Note 614D and the MMUTCD. Refer to Appendix 5 for MDOT Traffic and Safety Note 614D.

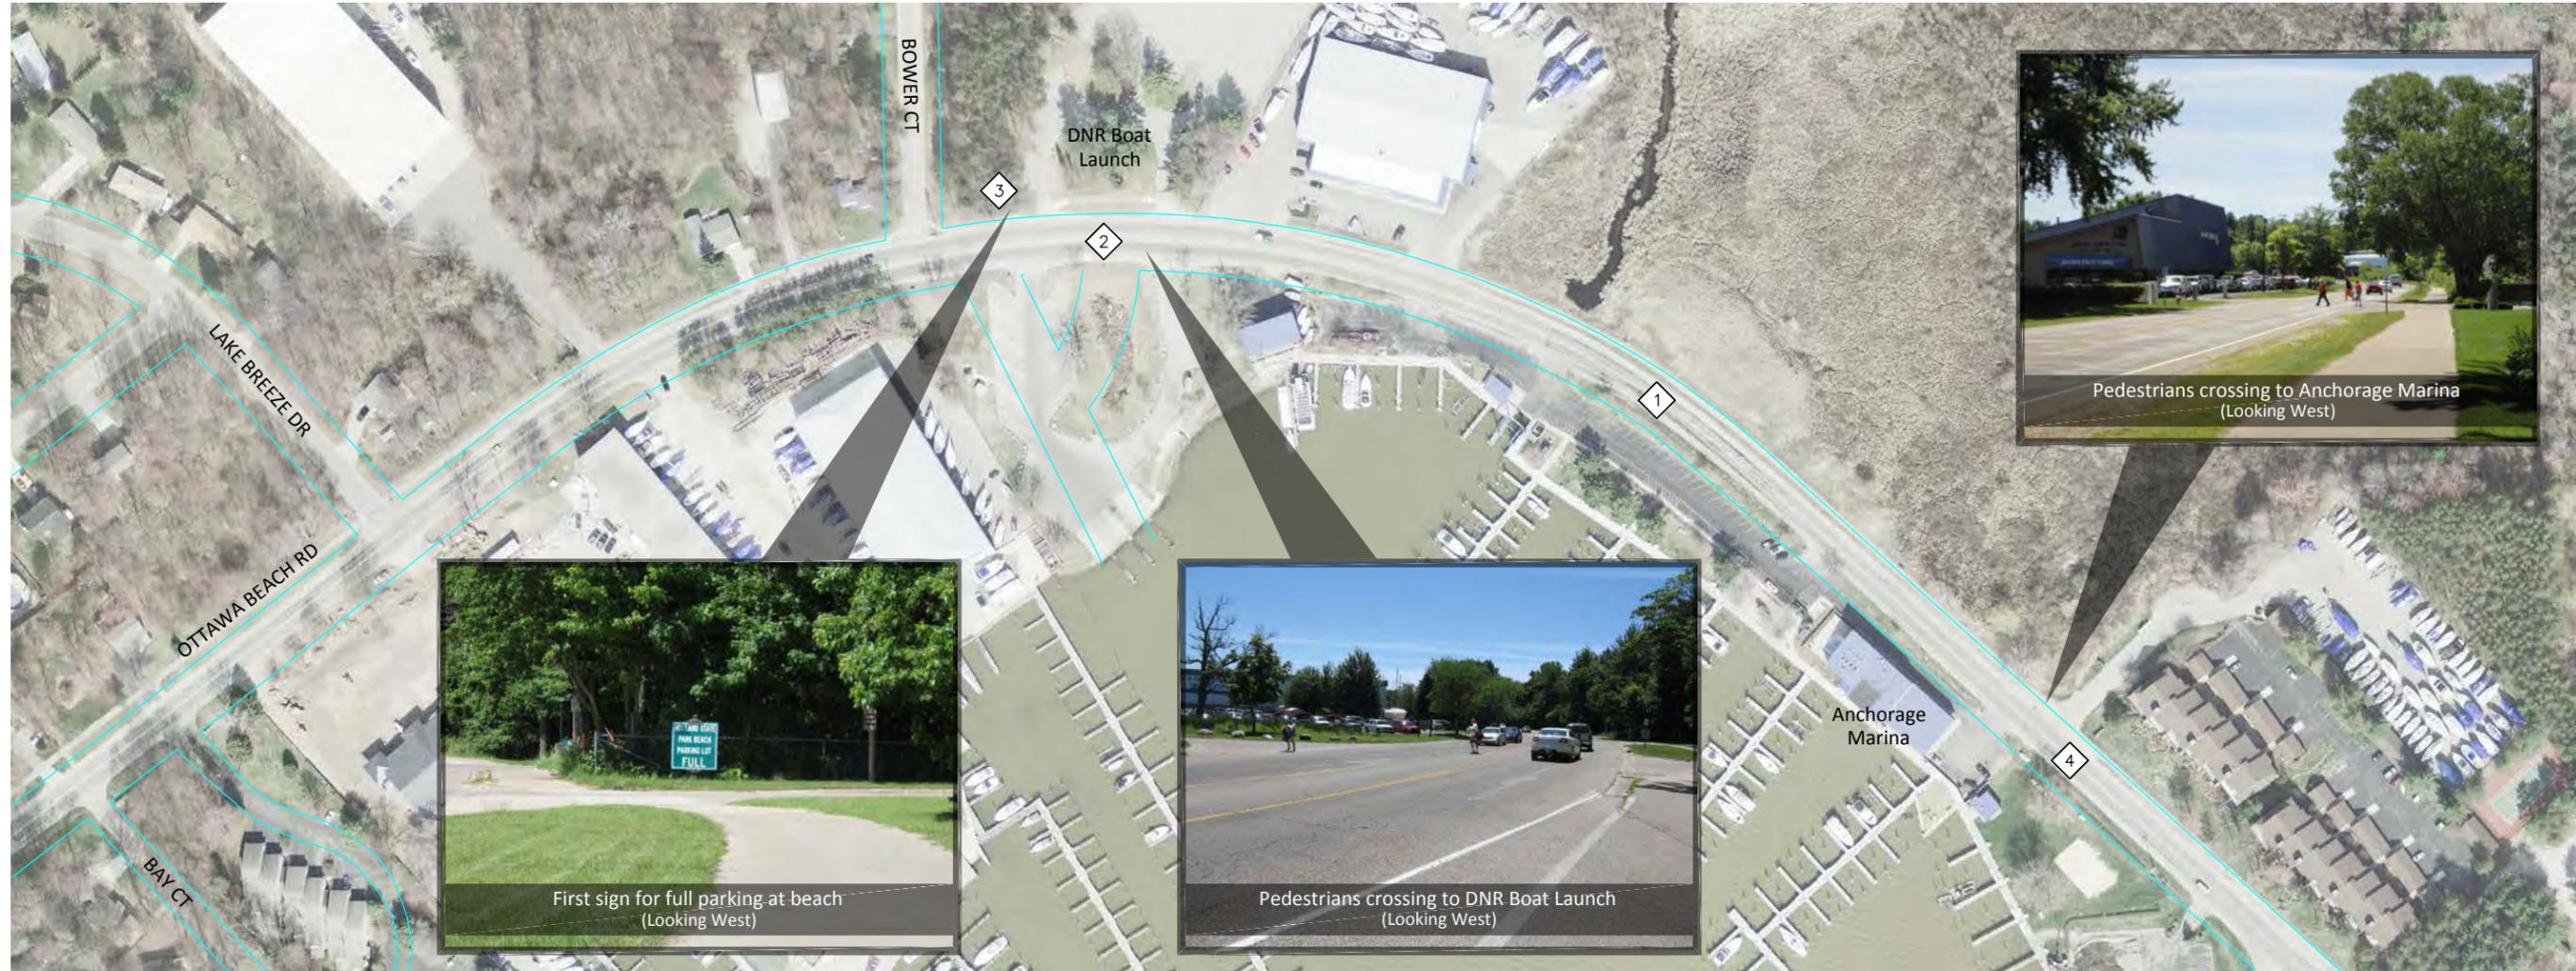
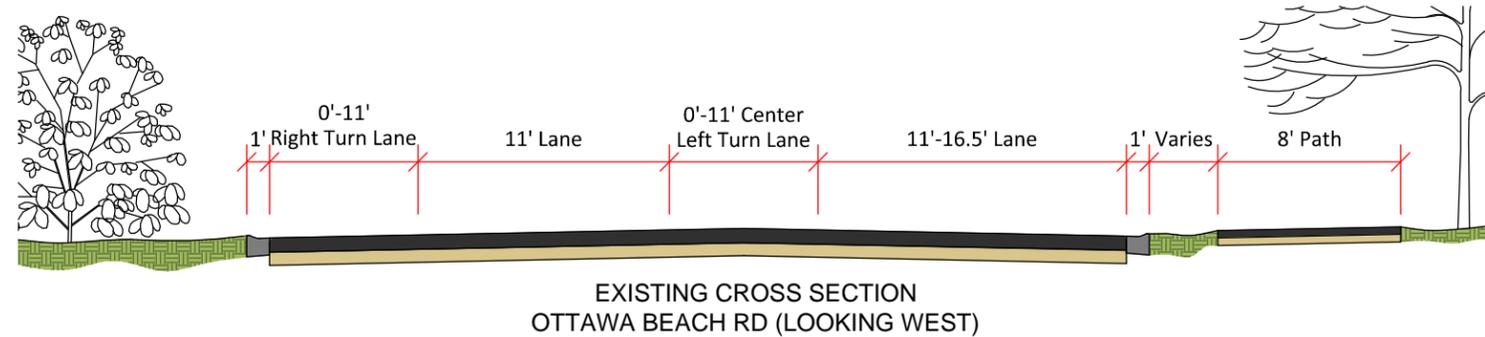
DNR BOAT LAUNCH EXISTING CONDITIONS

- 1 Tube Counter Location 3 for volume and speed data. ADT = 13,494 vpd, 85th Percentile Speed = 40 mph
- 2 The DNR Boat Launch is a one-way loop and is stop-controlled at the driveways.
- 3 First sign notifying vehicles that the Holland State Park beach parking is full. See photo.
- 4 Pedestrians cross to and from the Anchorage Condos to the Anchorage Marina but a crosswalk is not present. See photo. There is a pedestrian warning sign on the WB approach but not on the EB approach. Marina visitor parking is available on the north side.

2. Vehicles will enter the boat launch on the south side, launch their boat and if parking is full on the south side will cross the street to north side for parking.
3. Pedestrians need to cross the road to and from their vehicles but a crosswalk and sidewalks are not present. There is no warning for crossing pedestrians. See photo.
4. Sight lines for vehicles and pedestrians crossing the road are limited due to the curve of the road.
5. During peak periods, waiting vehicles will back up onto Ottawa Beach Rd.
