Ottawa Beach Road Study

**Prepared For:
Park Township**

**September 30, 2014
Project No. G140303**

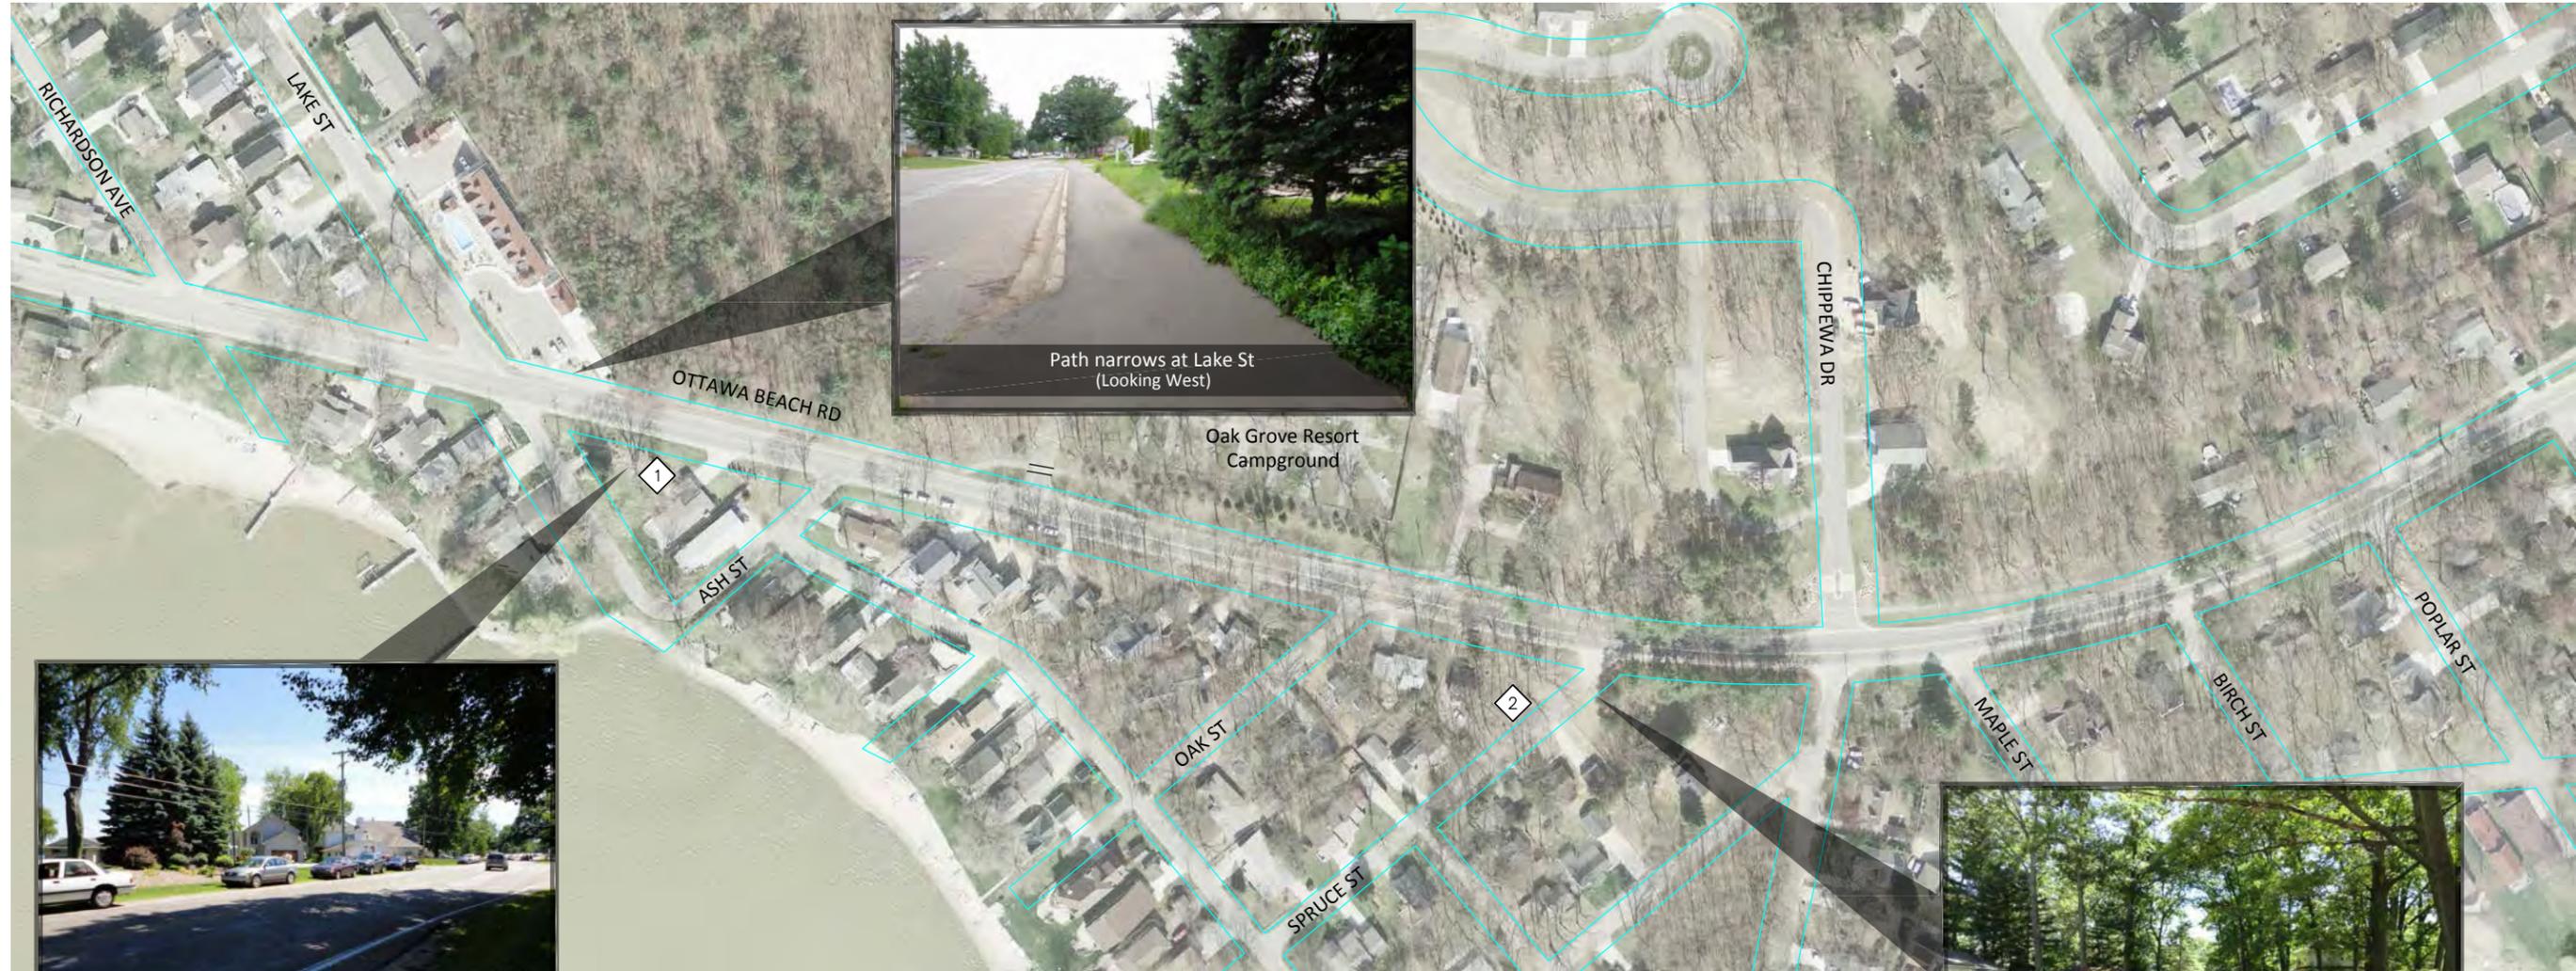
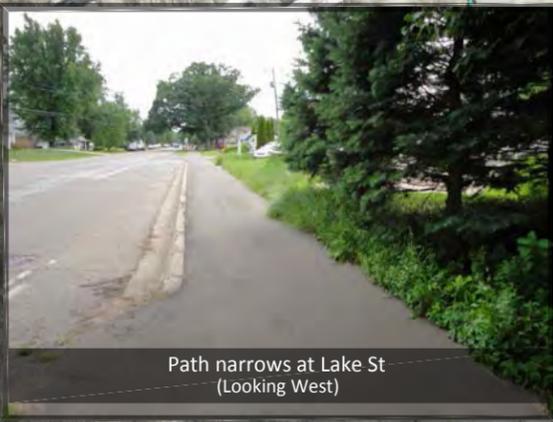
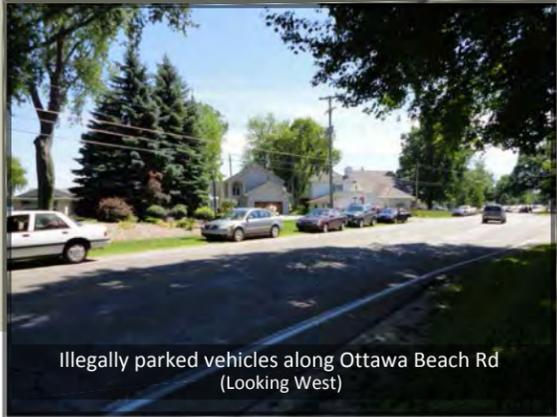
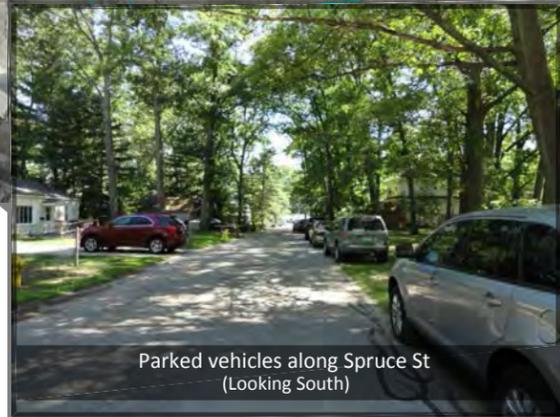
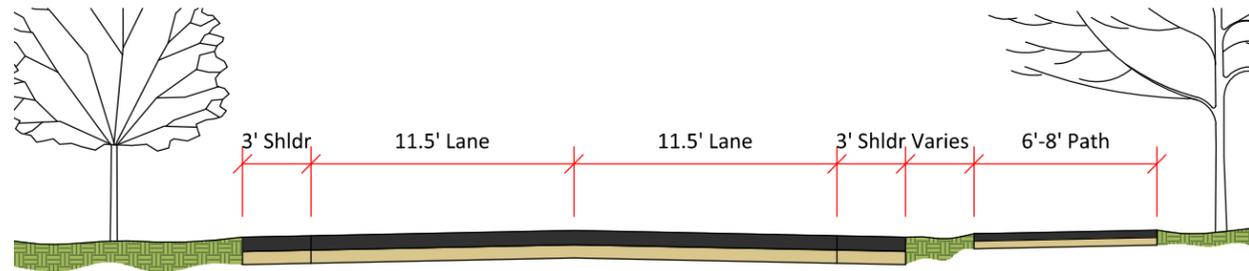
**POPLAR ST TO RICHARDSON AVE
EXISTING CONDITIONS**

EXISTING CROSS SECTION
OTTAWA BEACH RD (LOOKING WEST)

1. A right-turn lane is provided on Ottawa Beach Rd.
2. The path narrows to 6' at the right-turn lane. See photo.

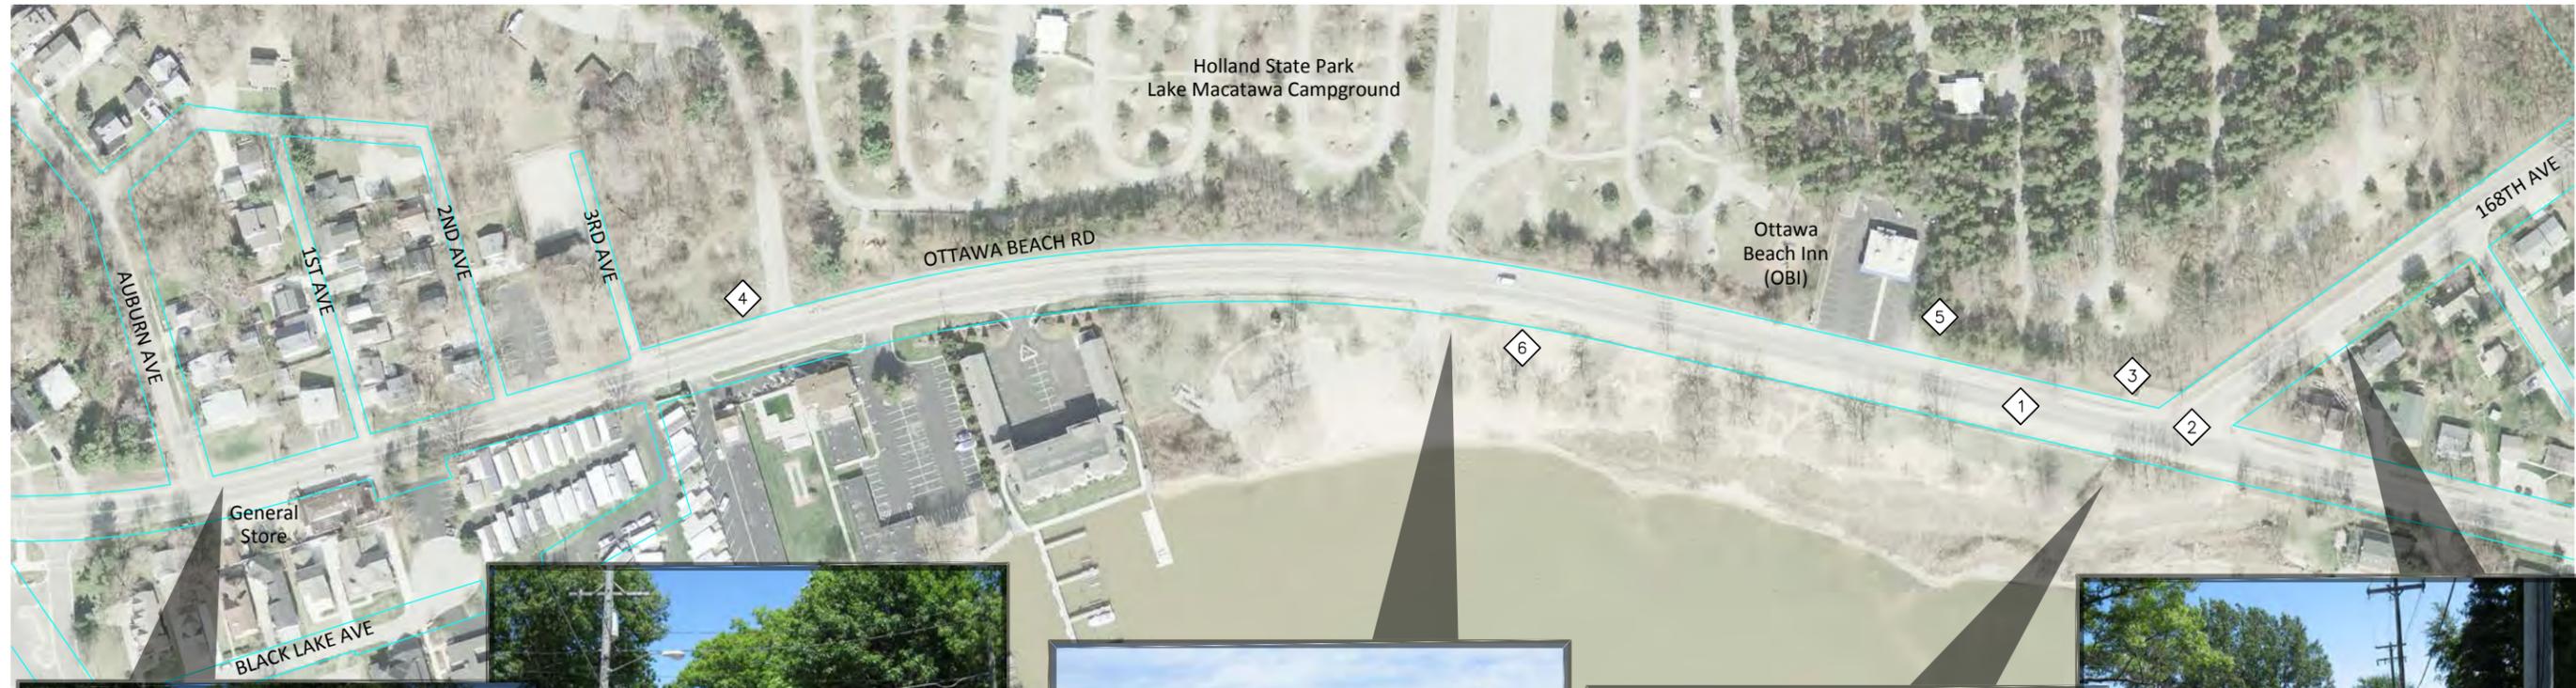
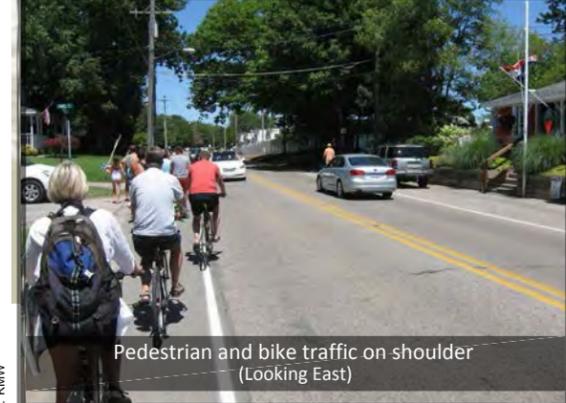
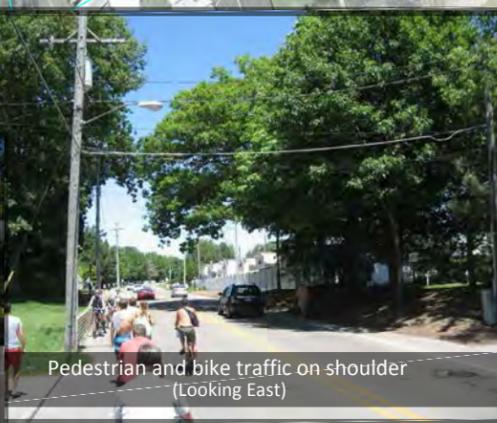
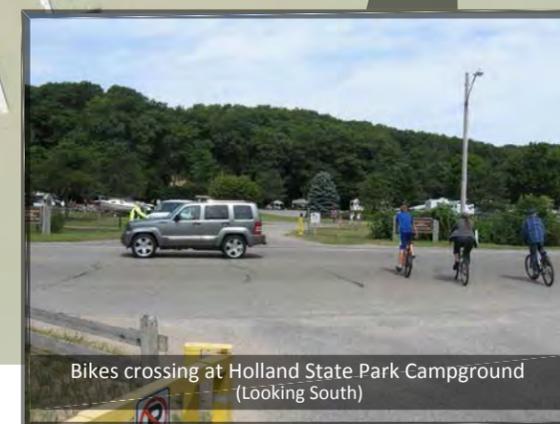
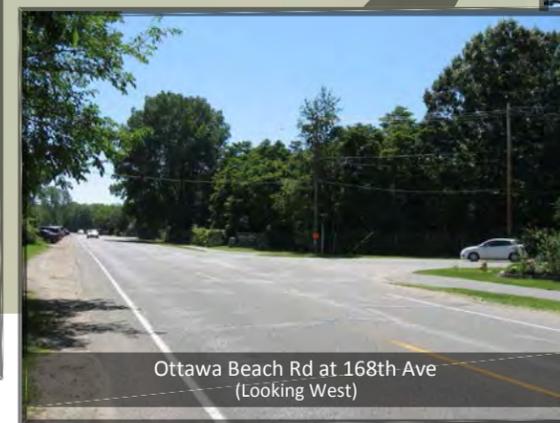
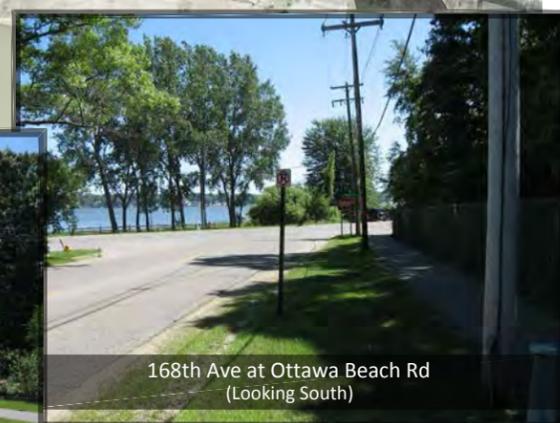
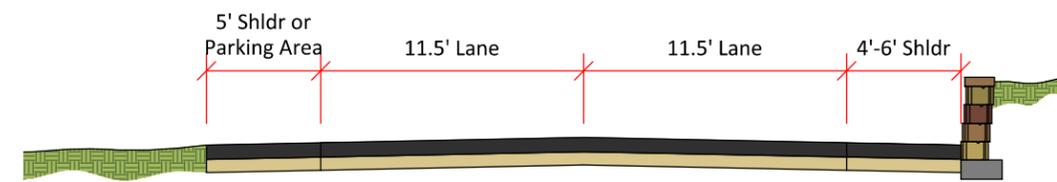
**168TH AVENUE TO GENERAL STORE
EXISTING CONDITIONS**

During the data collection process, high volumes of vehicular, pedestrian and bike traffic were observed in this area. The path transitions to a narrow shoulder and given the large amounts of pedestrian and bike traffic, some enter the road. Several pedestrians and bikes were also witnessed crossing the road to and from the General Store. No crosswalks are present near to the store.

EXISTING CROSS SECTION
OTTAWA BEACH RD NEAR THE GENERAL STORE (LOOKING WEST)

- GENERAL STORE**
1. Several pedestrians and bikes crossing the road to go to the store but a crosswalk is not present.
 2. The path transitions to a narrow shoulder and with the large amount of pedestrian and bike traffic, some are forced into the road. See photos.

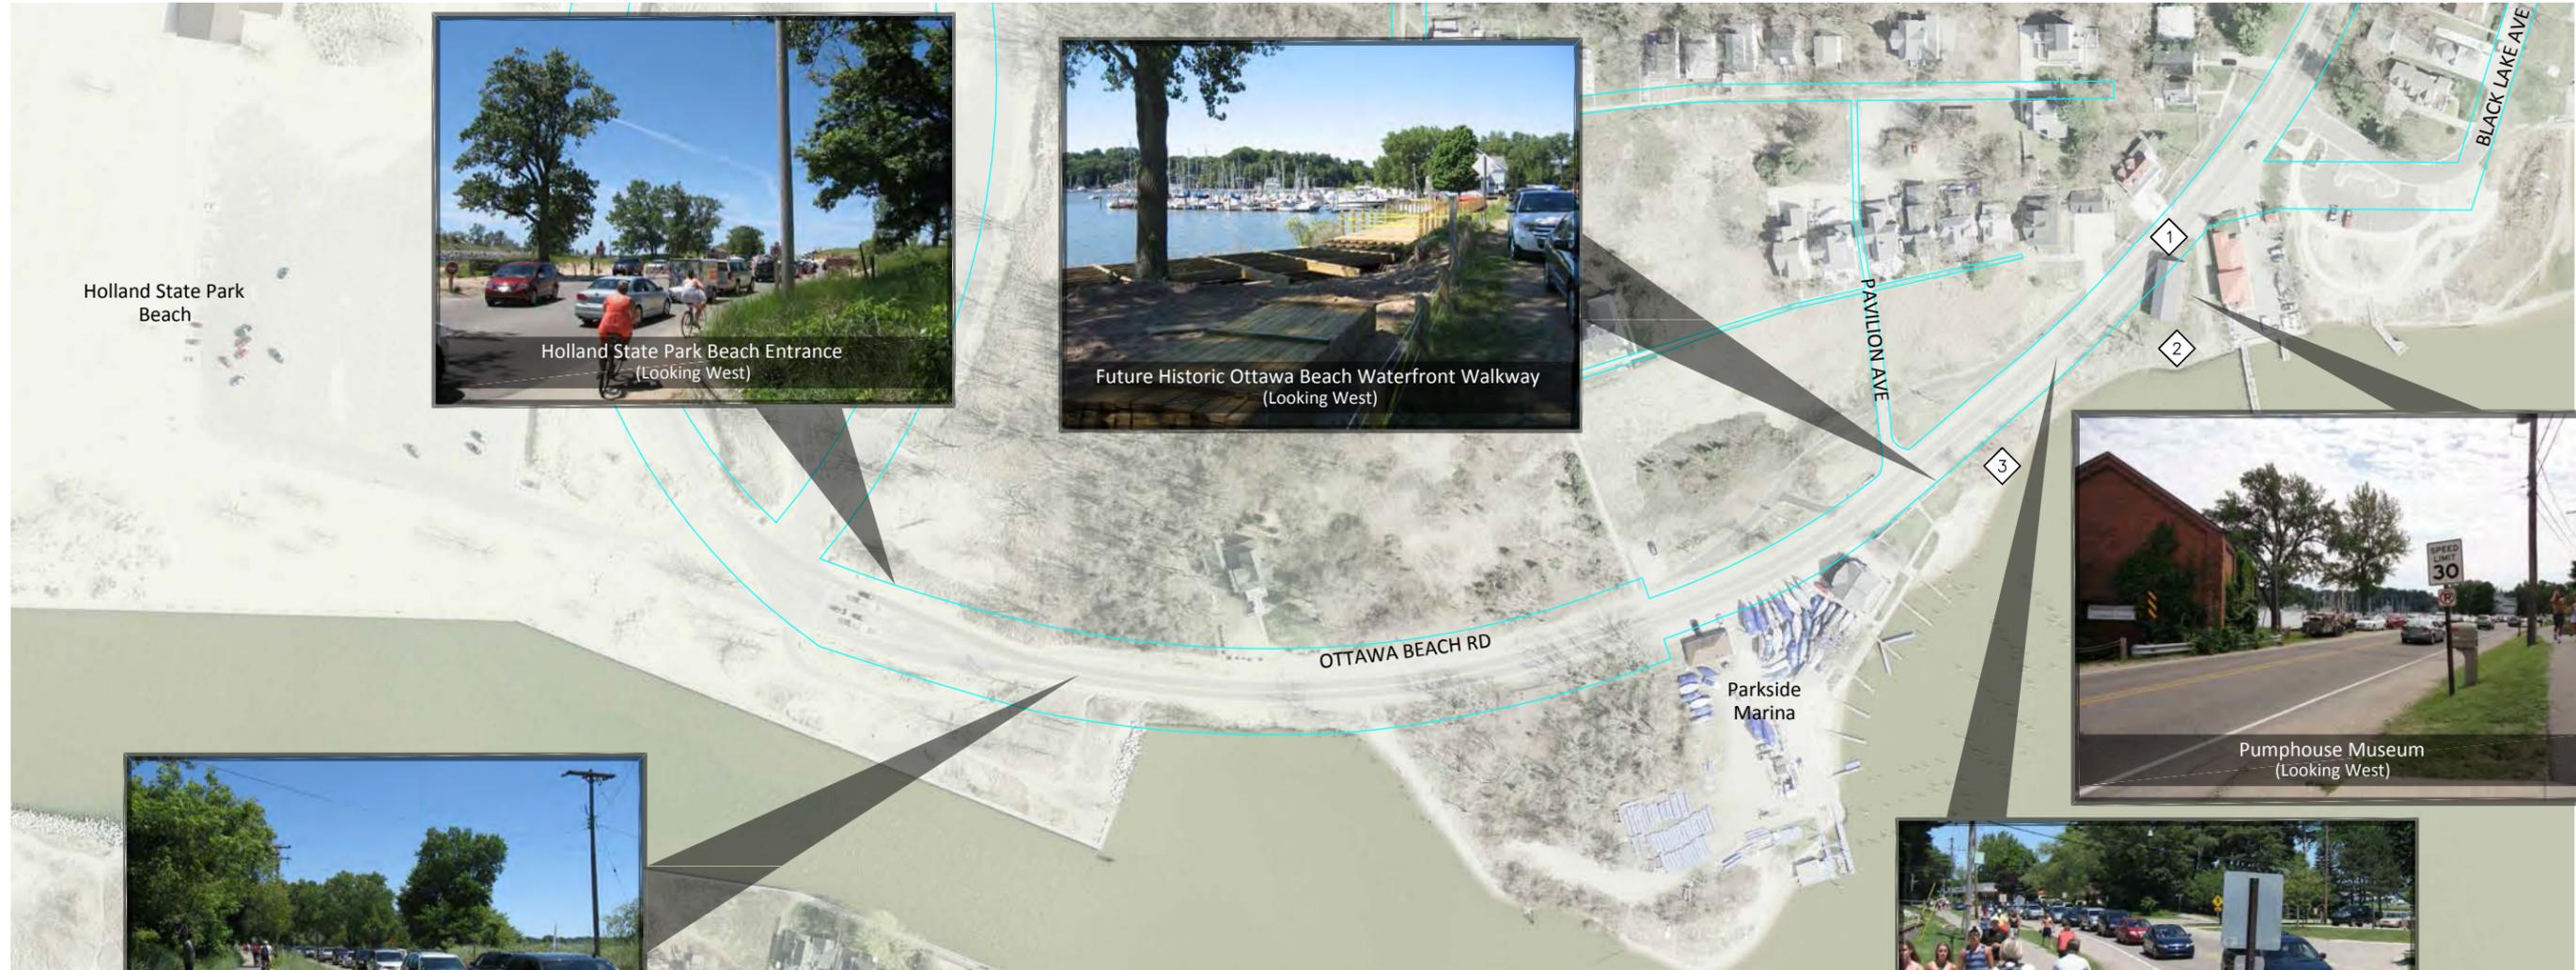
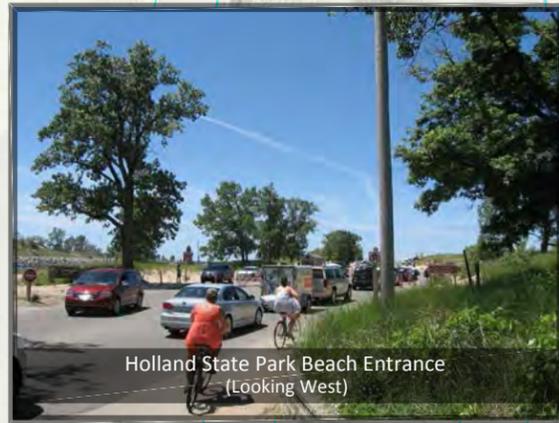
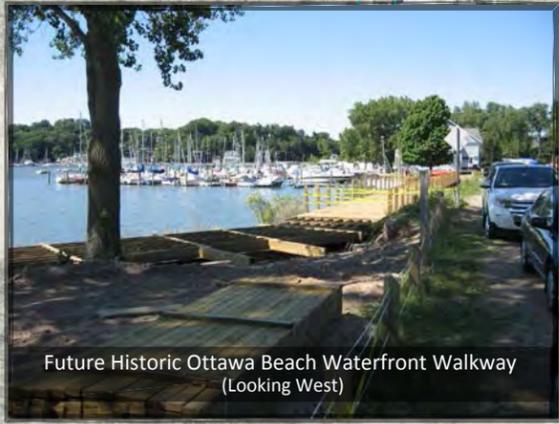
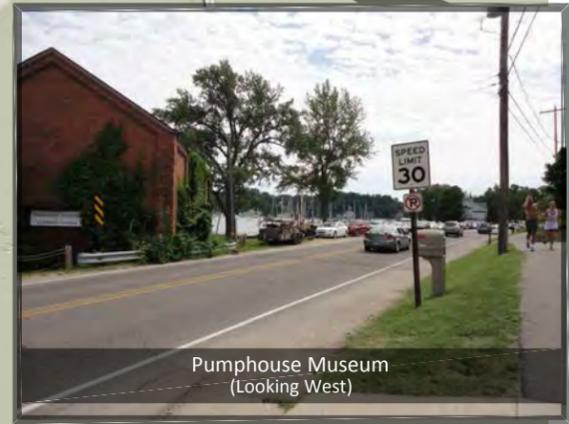
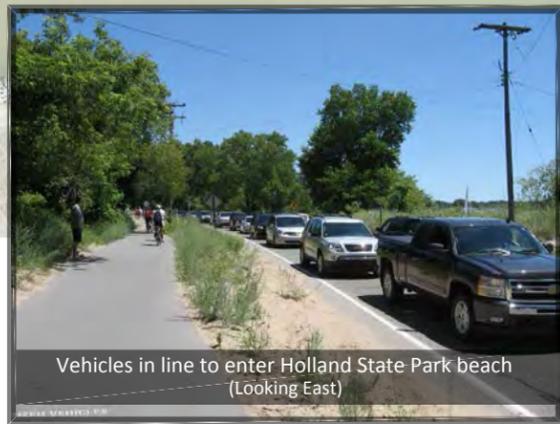
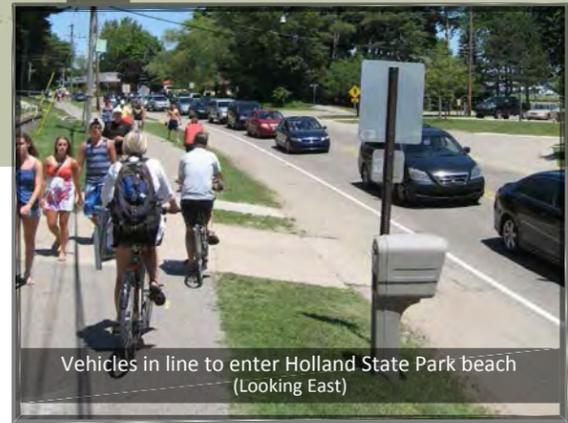
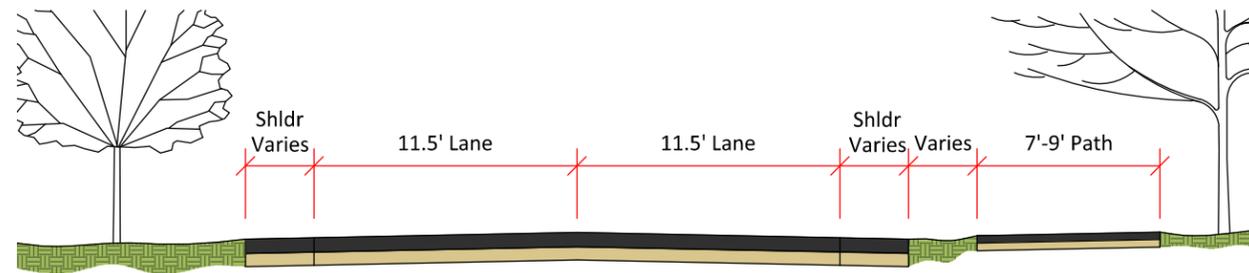
HOLLAND STATE PARK BEACH EXISTING CONDITIONS

EXISTING CROSS SECTION OTTAWA BEACH RD (LOOKING WEST)

1. Even though signs are posted that the beach parking is full, vehicles wait in line to enter the park and back up past the General Store during peak periods. See photos. Many u-turns on Ottawa Beach Rd were witnessed during data collection.

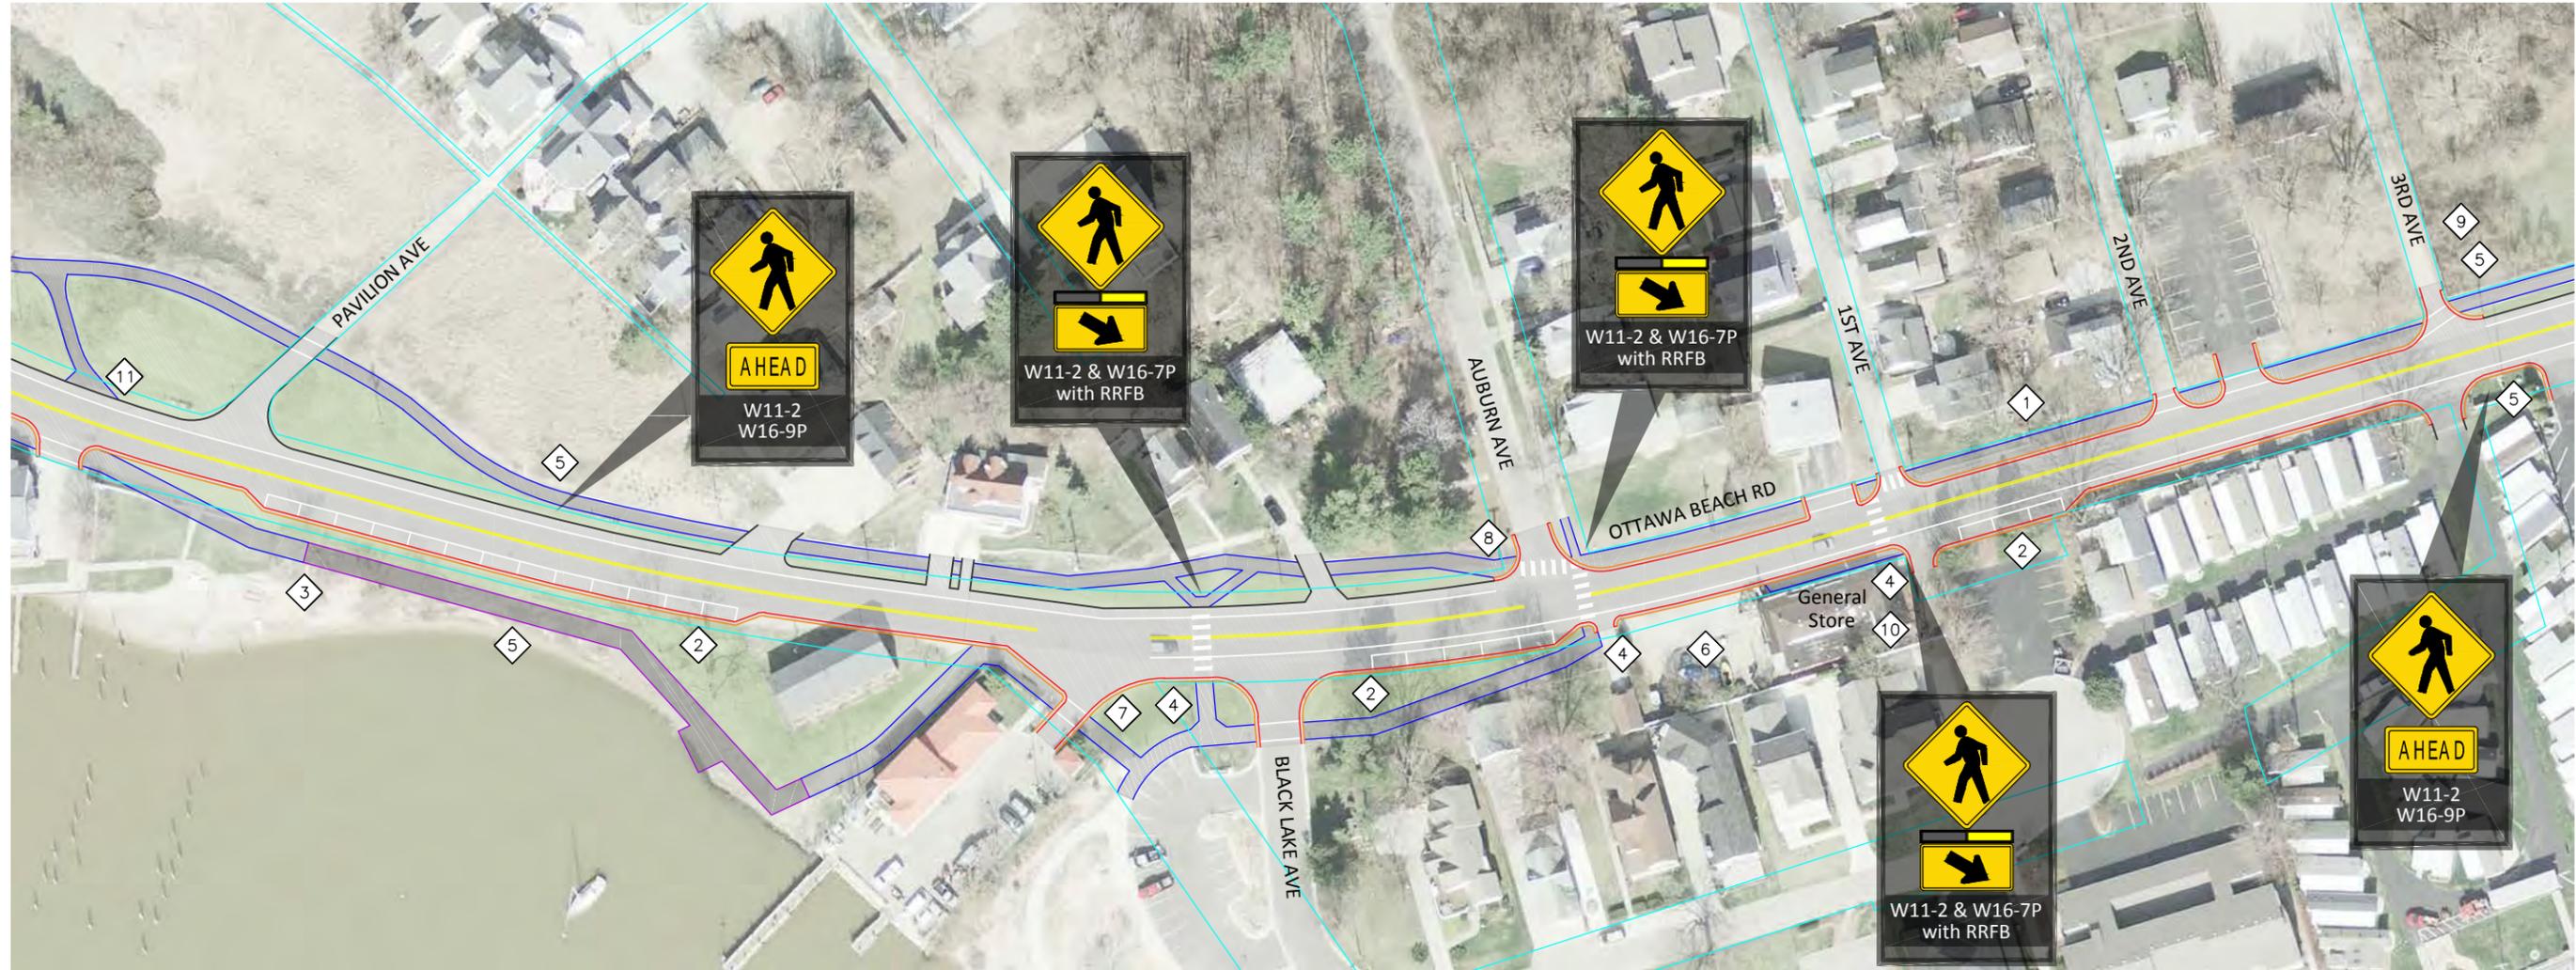
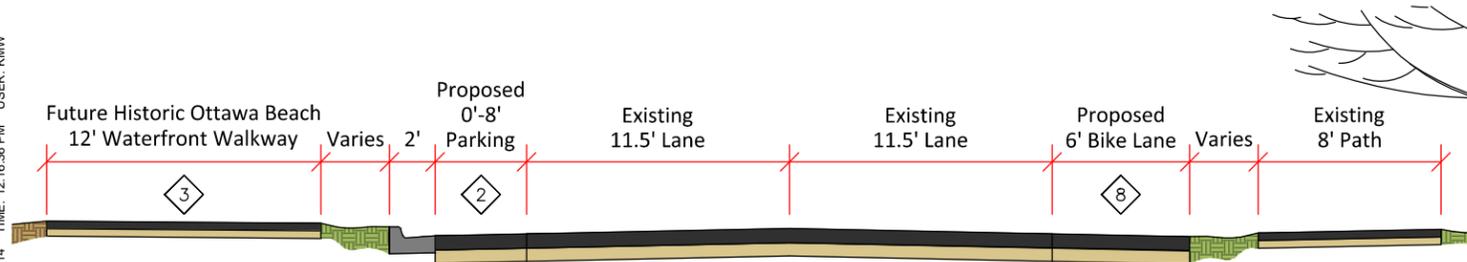
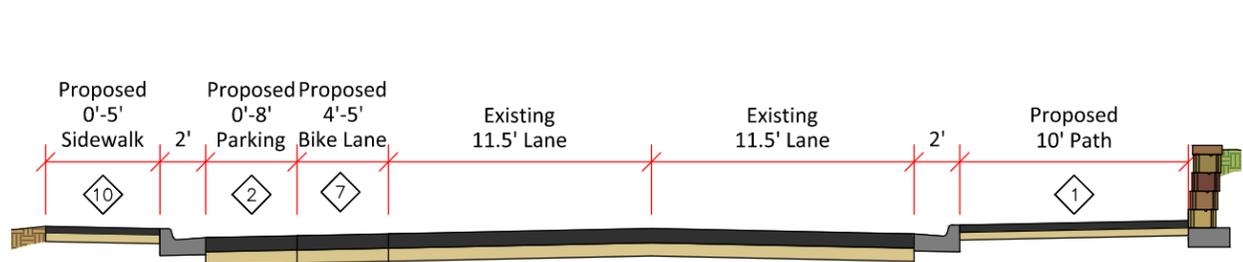
PROPOSED CROSS SECTION
OTTAWA BEACH RD NEAR HISTORIC OTTAWA BEACH WATERFRONT WALKWAY (LOOKING WEST)

PROPOSED CROSS SECTION
OTTAWA BEACH RD NEAR THE GENERAL STORE (LOOKING WEST)

Before developing recommendations, FTCH reviewed the Draft Park Township Master Plan (2011) and the Historic Ottawa Beach Waterfront Walkway Plan for future facilities recommended by the City. The Draft Master Plan calls for a multi-use path with a median on the north side of Ottawa Beach Road and a 5-foot bike lane on the south side. These improvements would require the removal of the existing retaining walls. The Historic Ottawa Beach Waterfront Walkway Plan proposes a 12-foot walkway on the south side with viewing and seating areas. Recommendations for the General Store area took these plans into consideration and are provided in Figure 12.

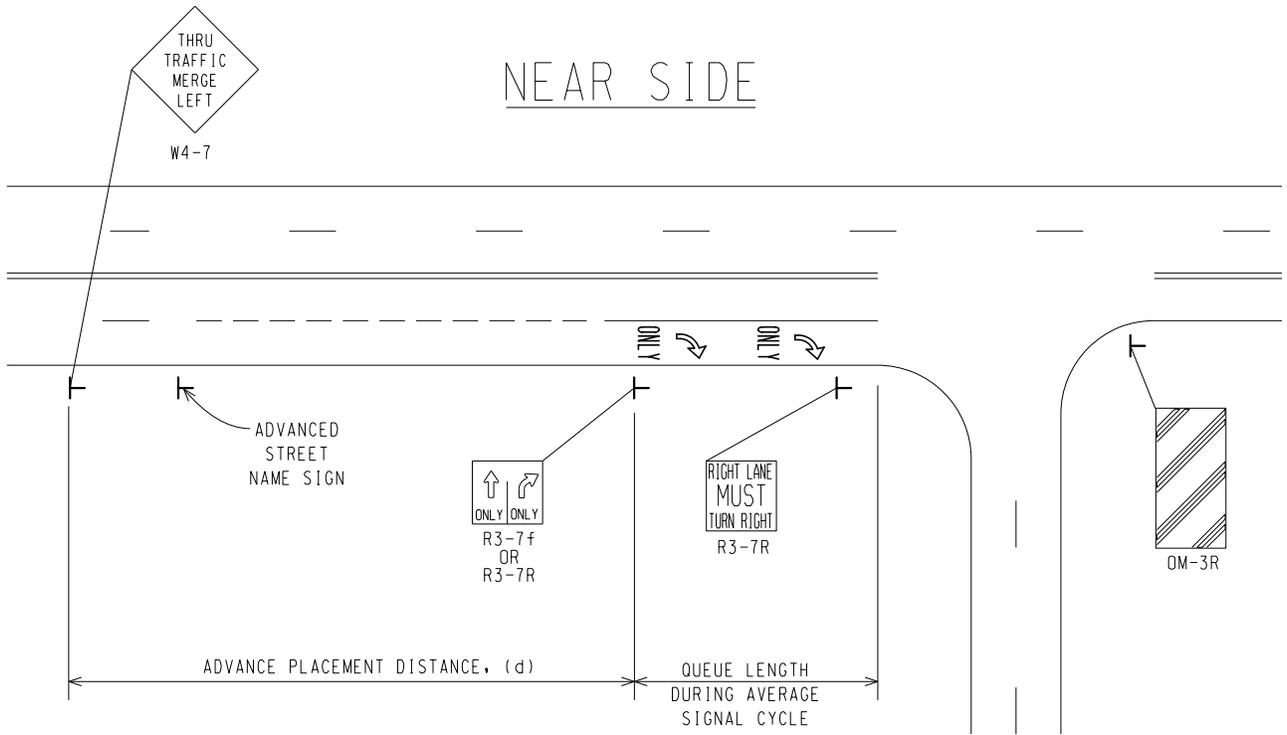
NEAR SIDE

5. Effective signing and pavement markings are necessary components to ensure a successful lane drop operation. The signing and pavement markings shown on the bottom drawing on page 3 are recommended for far-side intersection lane drops.

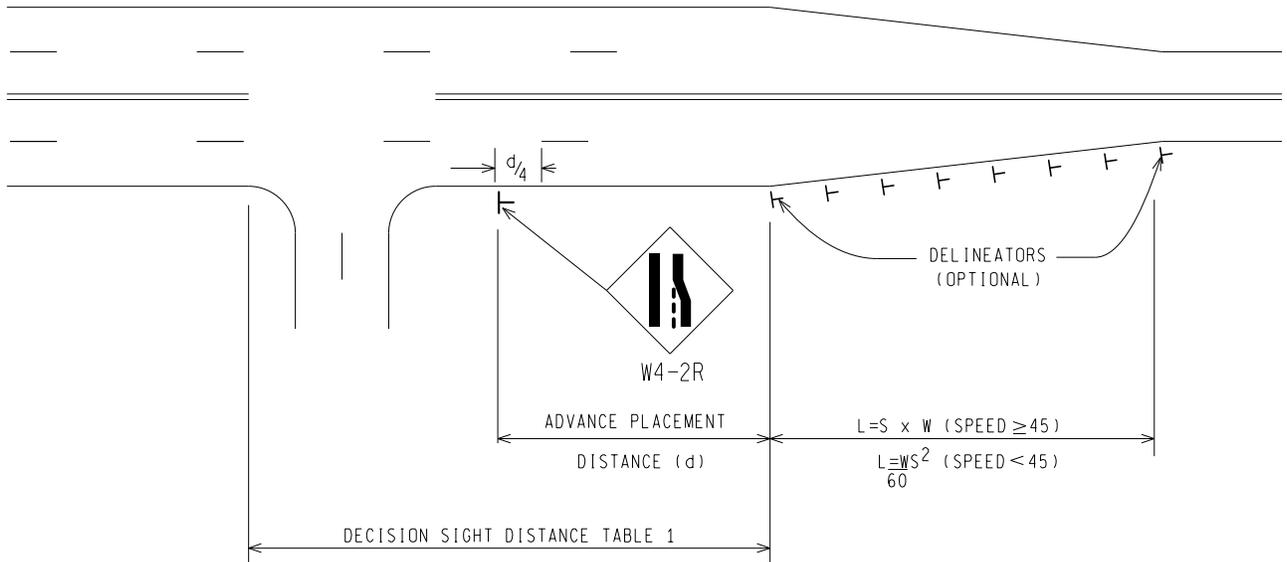
FAR SIDE

Advanced Placement Distance (d)
 See MMUTCD Table 2C-4
 Condition A
 Speed Reduction and Lane Changing
